## **SCIENCE and ART: A Future for Stone**

**Proceedings of the 13<sup>th</sup> International Congress on the  
Deterioration and Conservation of Stone – Volume II**

6<sup>th</sup> to 10<sup>th</sup> September 2016, Paisley, Scotland

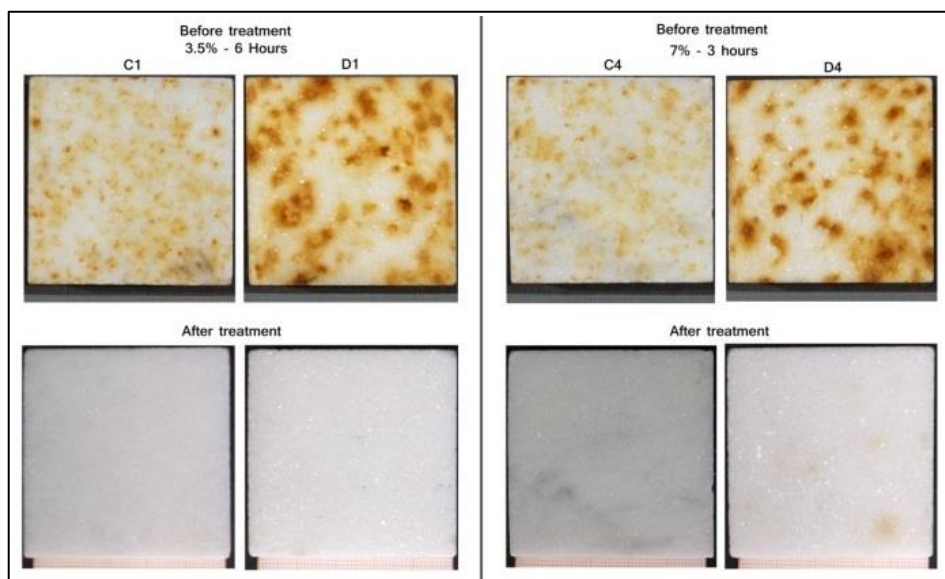
Fig. 1: Comparison between treatments on calcitic (C) and dolomitic (D) samples with SDT.

Fig. 1 shows the effects of the SDT cleaning intervention. Less concentrated solution applied for longer contact time (3.5% solution, 6 hours) removed the rust stains more efficiently than the more concentrated solution applied for shorter contact time (7% solution, 3 hours), especially in the case of dolomite. FT-IR analyses of the marble surface did not reveal any residual cleaning product, while XRF analyses showed minimal amount of iron on dolomite, not visible to the naked eye (Fig. 2).

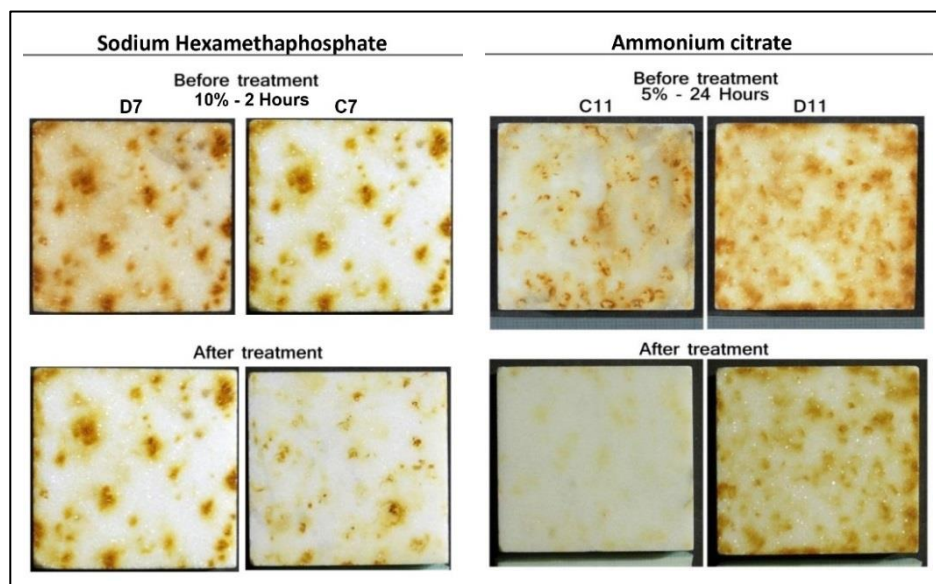
Fig. 4: Calcitic (C) and dolomitic (D) samples before/after application of Sodium Hexametaphosphate 10% (left) and Ammonium Citrate 5% (right).

Fig. 4 shows the results of cleaning with HMP and AC. Although the highest concentration and longest contact time reported in the literature were used for both of the products, the methods appeared less effective than SDT. The use of Agar instead of Cellulose did not improve the results. It can be noticed that only the most superficial rust stains were removed, particularly for AC, which resulted safe for the marble surfaces.

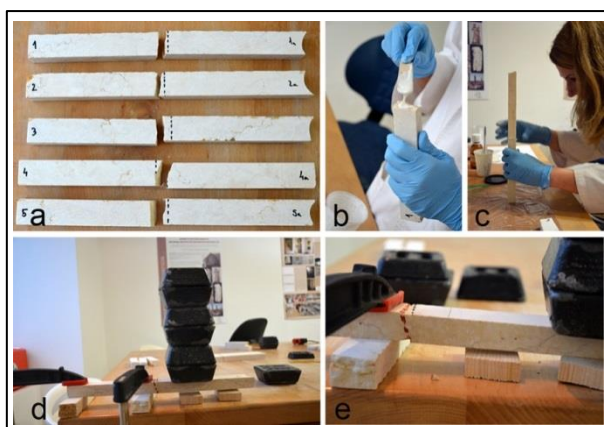
Fig. 1: Preparing samples and cantilever test: a – limestone samples; b – applying the adhesive mixture 1; c – setting of samples; d and e – cantilever test.

Tab. 2: Cantilever load test data at 7 days.

Sample No.	$P$ , N	$M$ , Nmm	$W$ , mm <sup>3</sup>	$\sigma$ , N/mm <sup>2</sup>
1	-	-	-	-
2	137.34	16480.80	2581.33	6.385
3	78.48	9417.60	2581.33	3.648
4	78.48	9417.60	2581.33	3.648
5	78.48	9417.60	2581.33	3.648
6	107.91	6474.60	2581.33	2.508

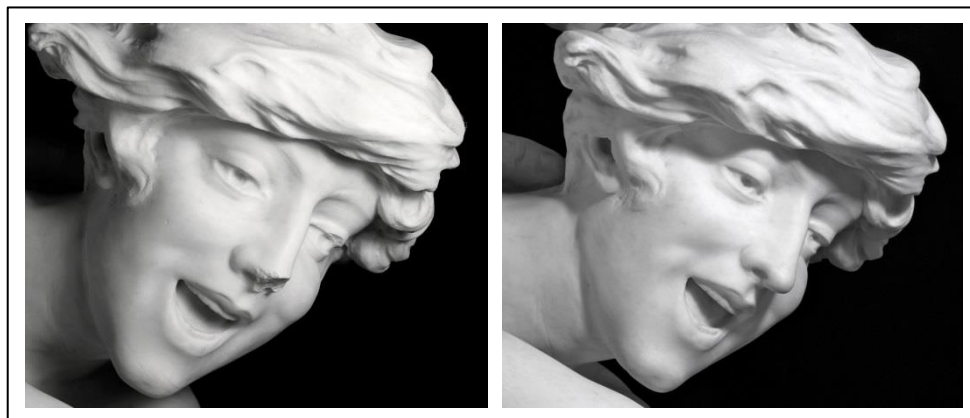
*Fig. 2: Reconstructed detail (tip of the nose) before and after. The head is approximately 25% over life-size.*

The colouring of the fills or reconstructions is also facilitated by the fast curing process. Fine colour nuances are achieved by adding thin layers with slight colour differences between them. Because the resin is translucent, the under-layers transpire through the surface layer, creating colour nuances that can approximate quite well the complex patinated surface of the surrounding original. Obtaining white colour values requires adding large amounts of glass microspheres, which decreases the strength of the cured fill.

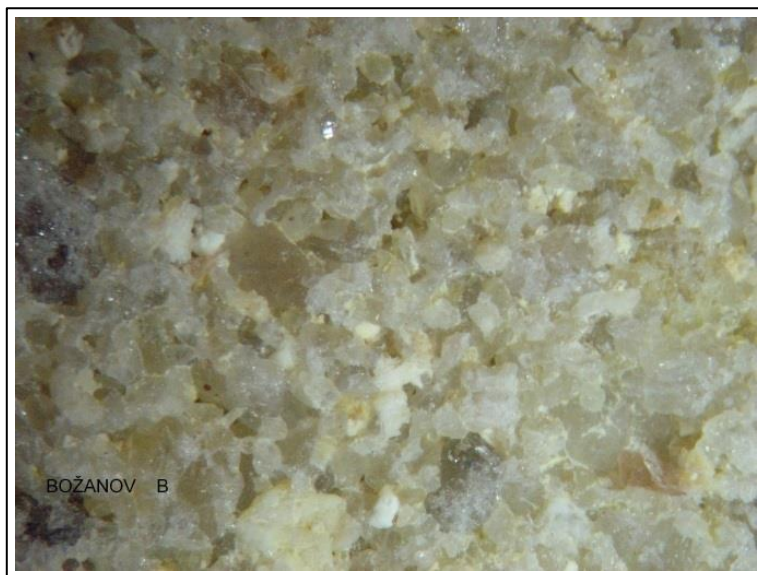
*Fig 1: Composition of the Božanov sandstone.*

Božanov Sandstone is one type of medieval stone used in the construction of the 14<sup>th</sup>-century Charles Bridge in Prague. Božanov stone is a greyish-beige gross quartz grain strong arkose sandstone without marked layering (Fig. 1). The material tested was extracted from the 11<sup>th</sup> arch of the Charles bridge parapet wall, which had to be replaced during recent repair because it has a rather deeply located detachment crack parallel to the surface, probably due to some previous surface treatment which locked moisture inside the stone. The material can be characterized as a quasi-brittle inelastic silicate composite.

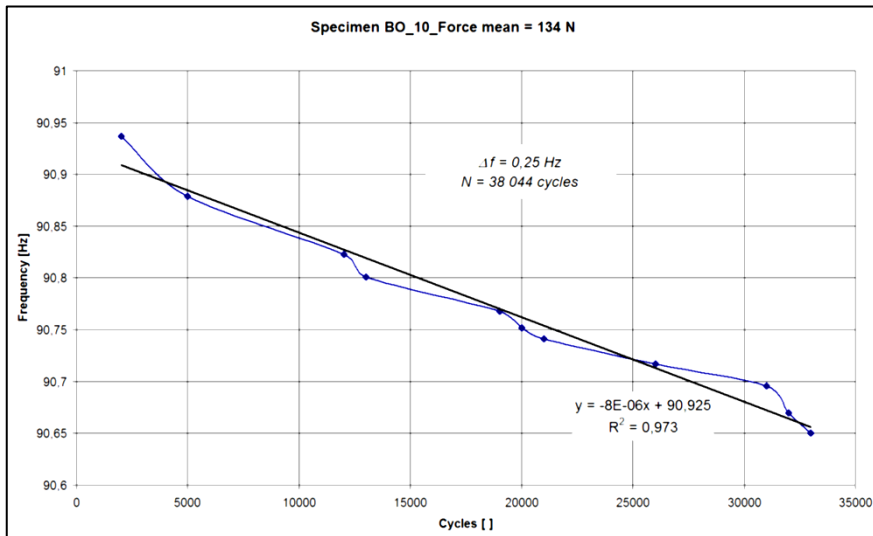
Fig. 3: Decrease of loading frequency during cycling of the specimen BO\_10 (for 134N).

Cycling the specimens in the high frequency resonance loading frame helped to understand fatigue behaviour of the Božanov sandstone. At a given force level (3PB arrangement under point load cycling from -10 N to -260 N) the majority of specimens exhibited fatigue life in a range between 90 000 and 140 000 cycles. However, there were specimens with one order lower or higher fatigue life due to the heterogeneity of the sandstone. To prepare the test specimens, a lower number of loading cycles was applied (between 32 000 and 40 000), and only specimens exhibiting behaviour similar to those of the above mentioned majority were accepted for further experiments. A typical record of the change of resonance frequency is presented in Fig. 3. Visible steps are the results of the regulation loop reaction which keeps the mean loading value within an interval of +/- 2 N.

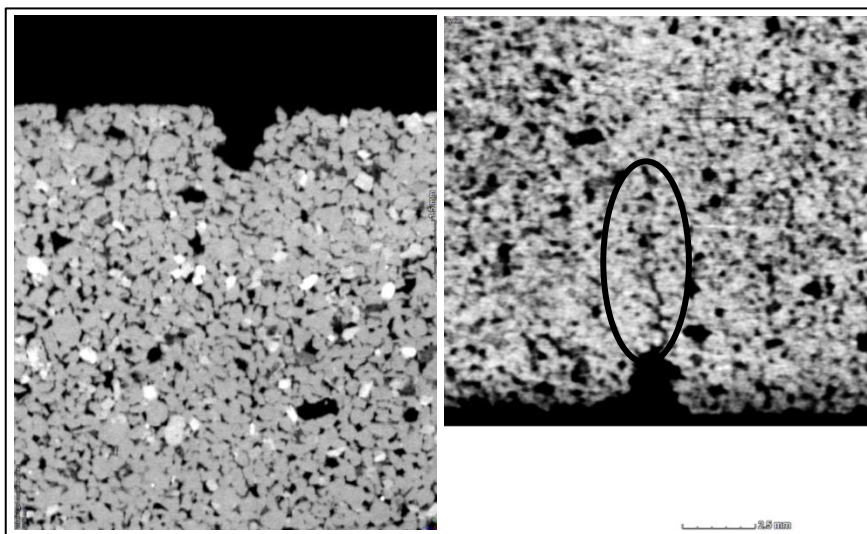
*Fig. 4: X-ray pictures of unloaded (left) and loaded (right) sandstone specimen BO\_5*

The character of the damage after cycling was determined by means of X-ray CT. It was not possible to identify the crack originating in the granular structure of the sandstone without applying a slight 3PB loading to the specimen and opening the crack. Thus, the specimen under investigation (BO\_5 after 140,300 cycles) was loaded with 200 N and under such loading scanned with the X-ray CT. Then the DIC method was used to identify similar situations within the sections in the specimen depth. DIC proved to be a useful tool for crack propagation studies, e.g. Lin and Labuz 2013. A comparison of crack visualisations for loaded and unloaded specimens is shown in Fig. 4.

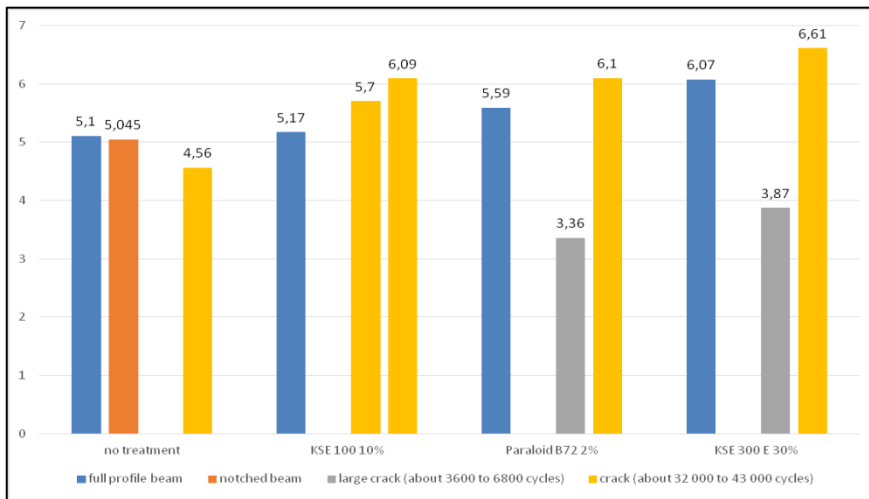
Fig. 5: Results of 3PB tests on four types of test specimens.

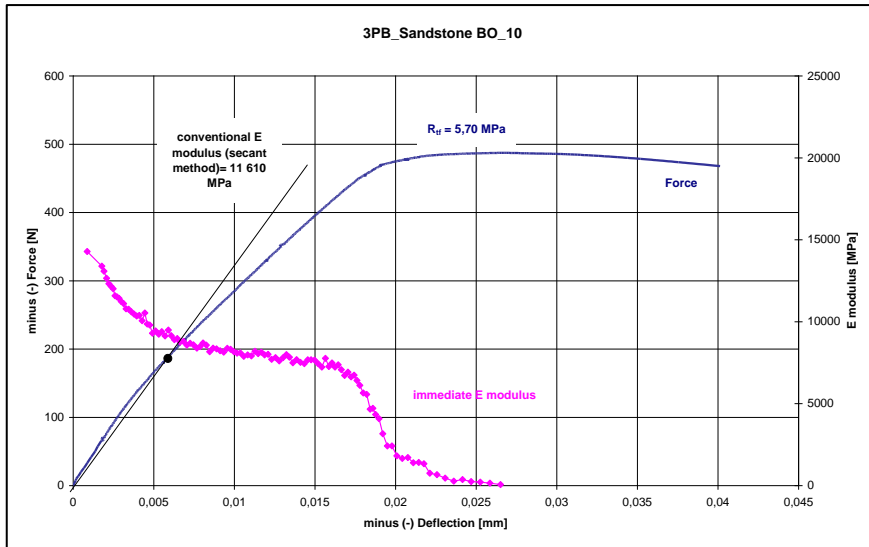
Fig. 6: Summary diagram for 3PB test of the specimen BO\_10.

The acquired ultimate loads were used to calculate  $K_{IC}$  toughness (Gross 1965), which attained the value of 0.331 for the notched beam, 0.349 for the notched beam with the crack and from 0.449 to 0.561 for the consolidated cracked beam in  $\text{MPam}^{0.5}$ . The toughness values are approximate estimates based on an engineering approach to the crack depth assessment from the above mentioned X-ray CT scans and the DIC reconstructions.

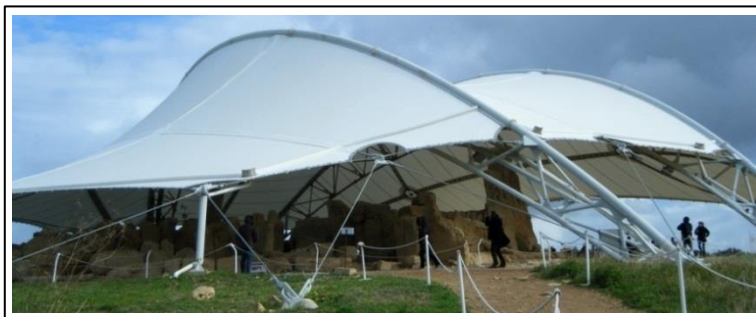
Fig. 1: Shelter over the megalithic temples at Hagar Qim, Malta.

Scientific Committee for Stone ISCS, 2008). An open shelter (without lateral cladding) was installed over the remains in 2008 to reduce environmental risks (Fig. 1).

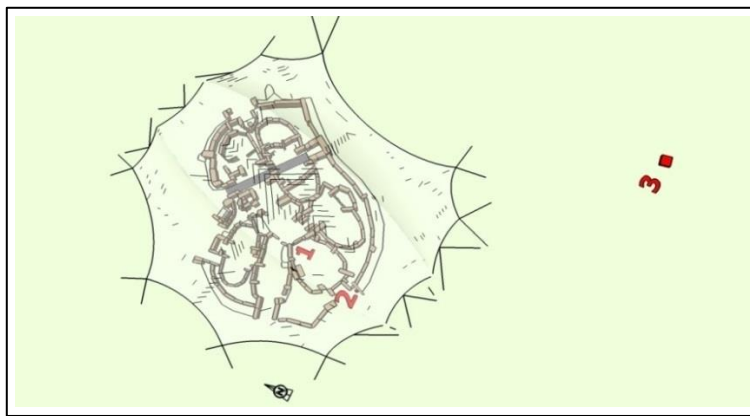
Fig. 2: Monitoring positions – 1: centre, 2: periphery and 3: outside of the shelter.

Low-cost and easy to hide temperature and *RH* loggers (i-button® hygrochron dataloggers, accuracy =  $\pm 0.5\%$  *RH* and  $\pm 0.5^\circ\text{C}$ ) were synchronised to record at all three positions every 60 minutes. From the data collected, the number of times a day *RH* crossed the 75% threshold was used as proxy for NaCl crystallisation events. The amount of dust deposited on horizontal surfaces inside and outside the shelter was studied using self-adhesive,

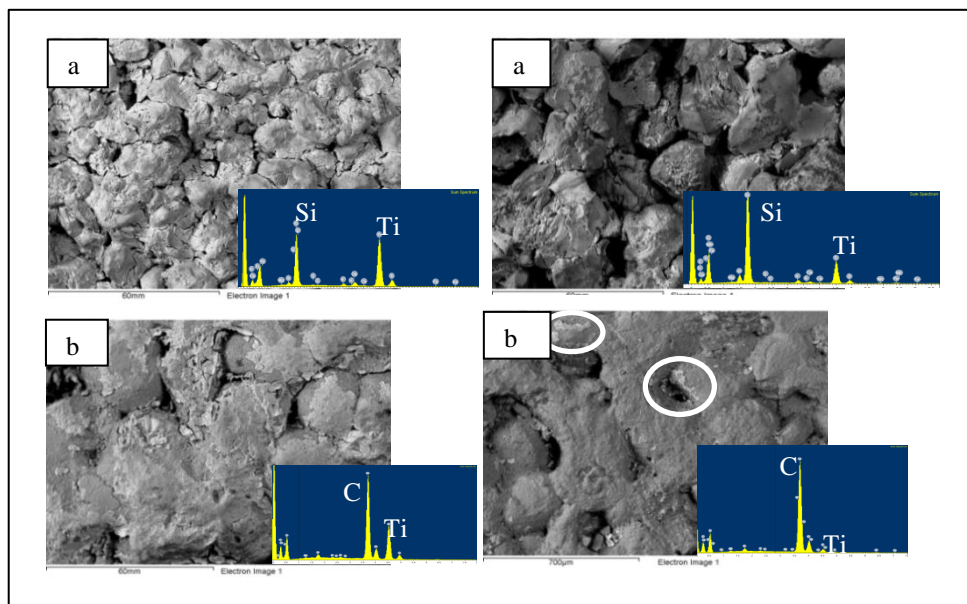
Fig. 4. SEM images and EDS analysis of the coated (2 layers) sandstone (a) and limestone (b) before (1) and after (2) six months of weathering (traces of the coating marked with a circle)

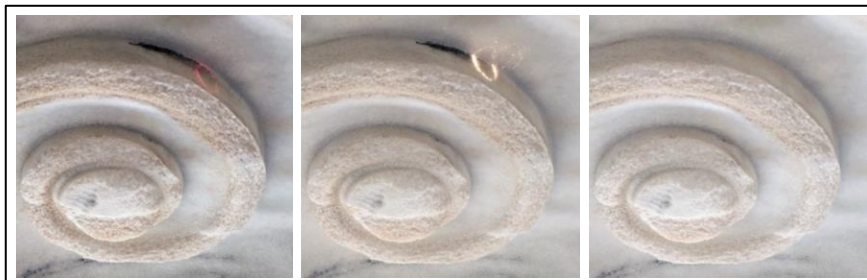
*Fig. 4: The red aiming beam of the GC-1 is used to target an area of architectural marble before firing the laser to remove dark gypsum crust.*

glass, not to mention potentially erode the stone surface. The GC-1 laser system has a red aiming beam feature that can be activated to show exactly where the laser will fire (Fig. 4). When the trigger is pulled, the red aiming beam is replaced with the 1064 nm laser beam that does the ablation.

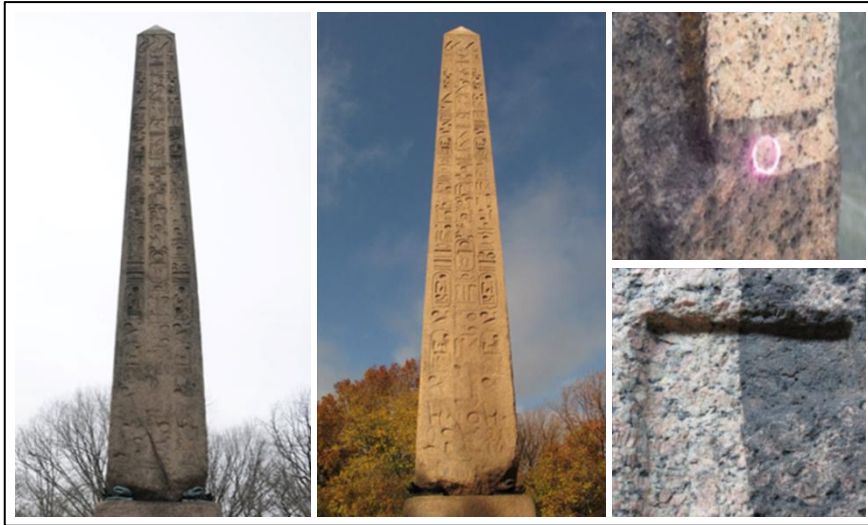
Fig. 8: Overall and detailed results of laser cleaning the obelisk.

The granite surface was examined with a portable USB microscope during treatment to ensure that no damage was being done to the surface. Photomicrographs were taken to document the cleaning results. Fig. 9 shows a one area before and after laser cleaning in regular light and infrared light. IR light helps show carbon on a surface. The images show that the soiling was successfully removed and that the black biotite inclusions, pink quartz, white quartz, and other minerals were not damaged during the cleaning process. In fact, the green arrows point to two small grains of quartz on the surface which are not disrupted at all by the cleaning process and remain intact.

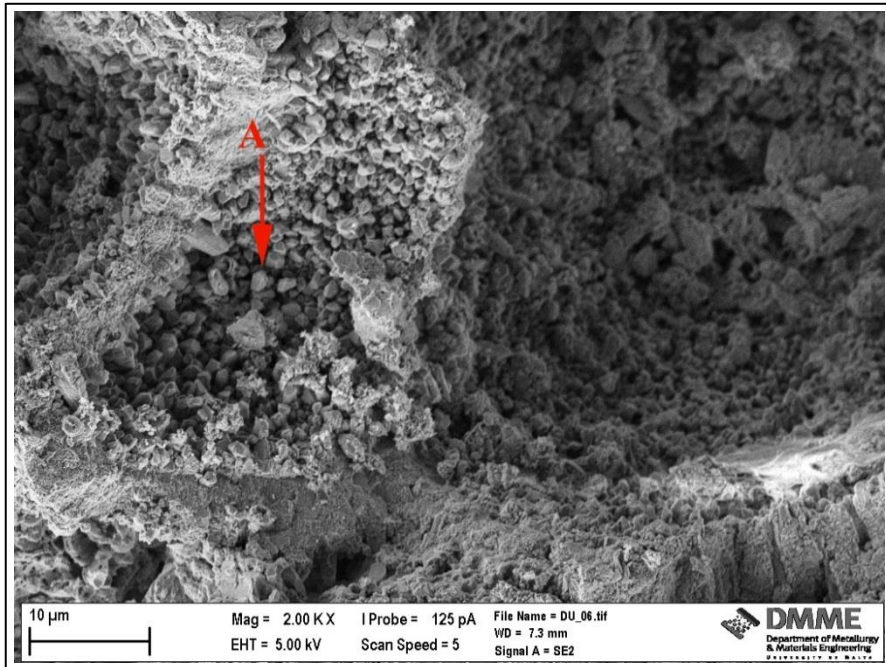
Fig. 1: SEM image ( $\times 2000$ ) for desalinated untreated laboratory sample.

For SEM analysis a Merlin FESEM with Carl Zeiss optics and Gemini II column (s/n: 4216) was used. In the SEM images of the desalinated untreated samples at  $\times 100$ , individual calcite crystals/granules were observed together with globigerinae and other fossils. In the treated samples, the microfossils were still visible and the previously individual crystals/granules were seen to be more compact. These findings suggest that treatment results in an improved and more compact surface texture without blocking the globigerinae/fossils. At higher magnifications ( $\times 2000$ ) the desalinated untreated samples showed that individual crystals/granules (A) were clearly distinguishable, (Fig. 1). In the treated samples (Fig. 2), the newly formed calcium oxalate was observed to take the form of flat crystals/plates which were arranged in a layered arrangement/stacked parallel to the sample surface (B). This arrangement is schematically illustrated in Fig. 4.

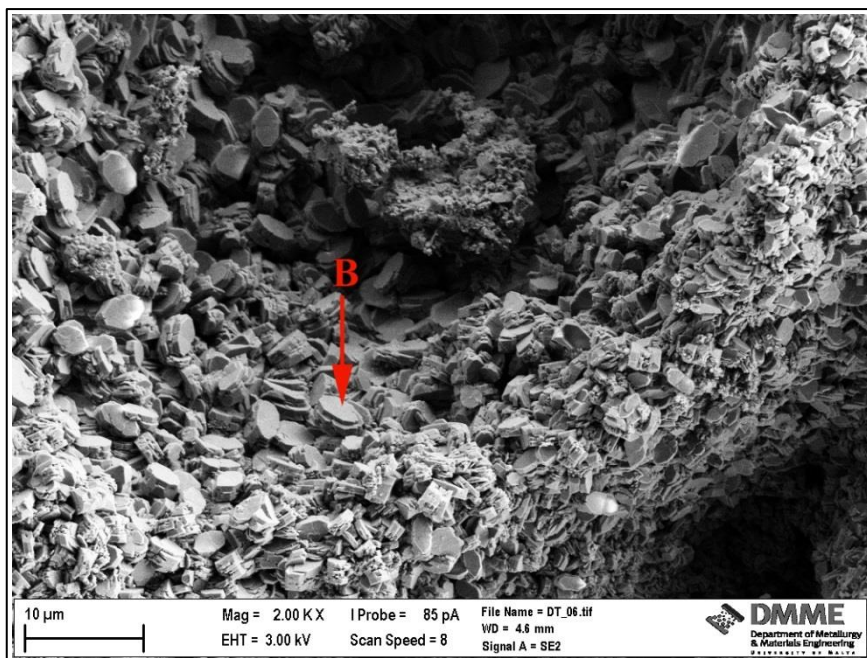
Fig. 2: SEM image (x 2000) for desalinated treated laboratory sample.

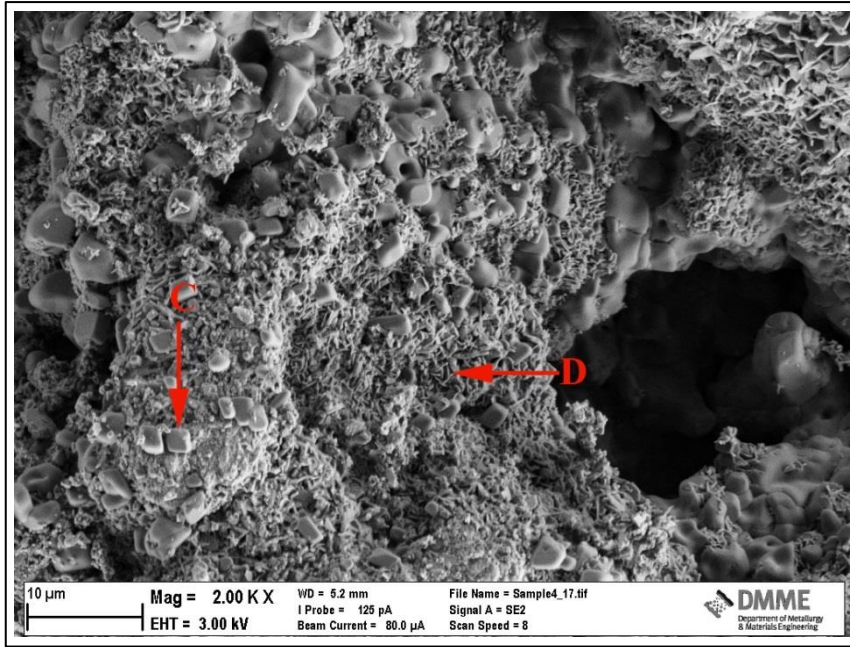
Fig. 3: SEM image (x 2000) for sodium nitrate contaminated treated laboratory sample.

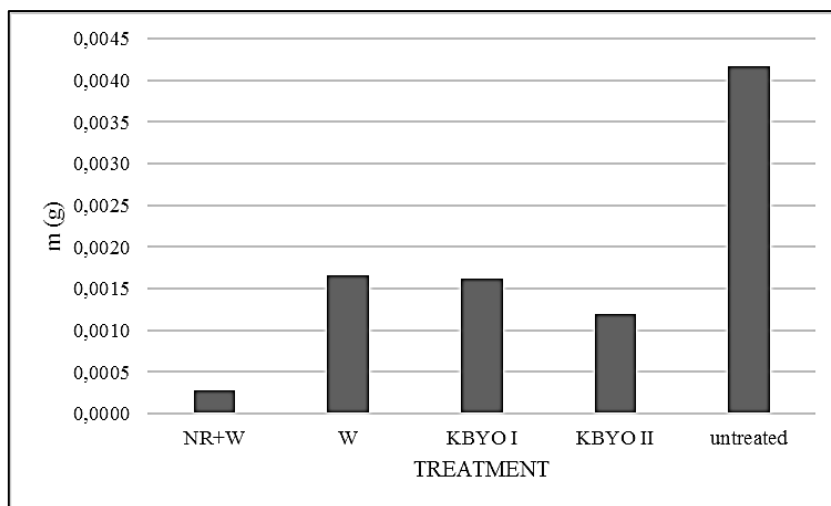
Fig. 1: Mass of adhered matter on adhesive tape for each treatment.

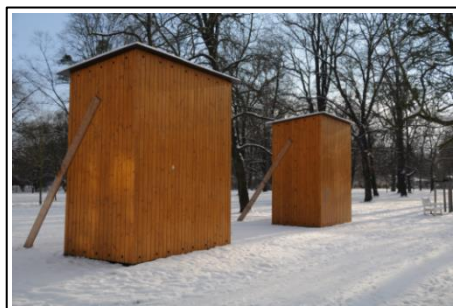
*Fig. 1: Dresden (D), Blüherpark, wooden boxes.*

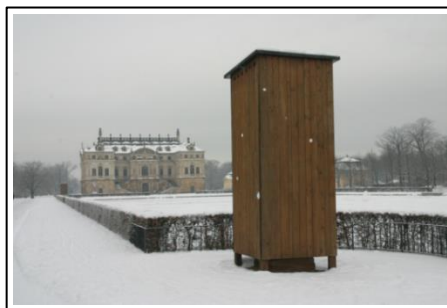
*Fig. 2: Dresden, Großer Garten, wooden boxes.*

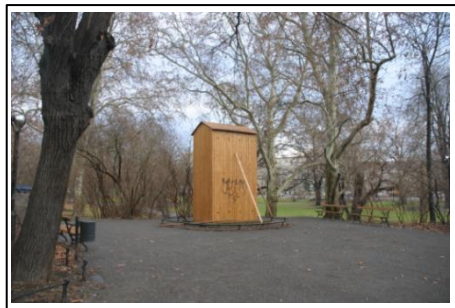
Fig. 3: Wooden box, City of Leipzig(D).

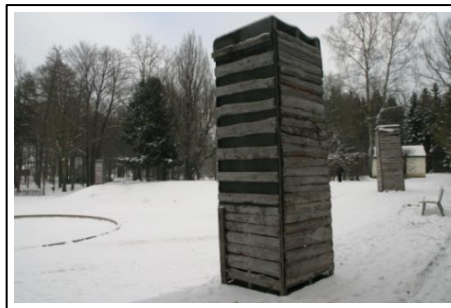
Fig. 4: Wood and tarboard box, Großharthau.

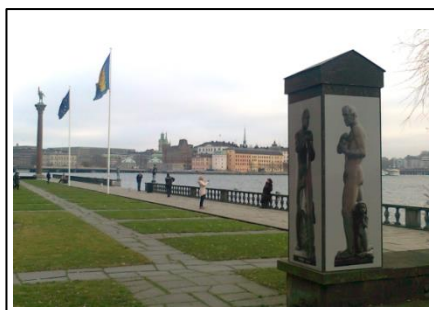
*Fig. 7: Stockholm, Stadthuset, wooden box.*

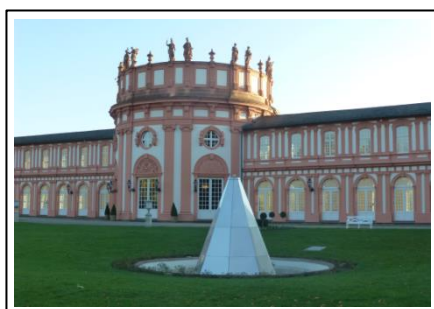
*Fig. 9: Biebrich Castle (D), metal cover.*

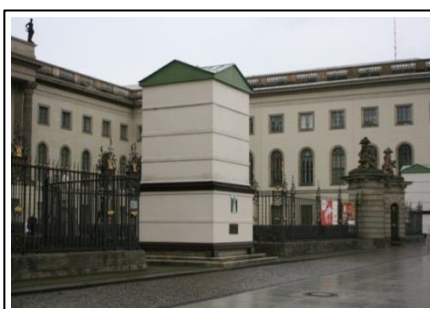
*Fig. 10: Berlin (D), metal house.*

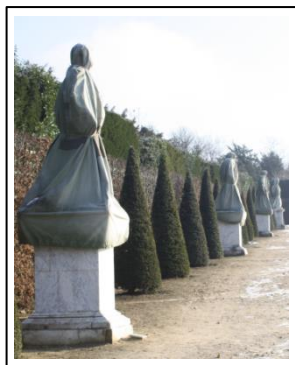
Fig. 11: Versailles (F),  
cotton wrapping.

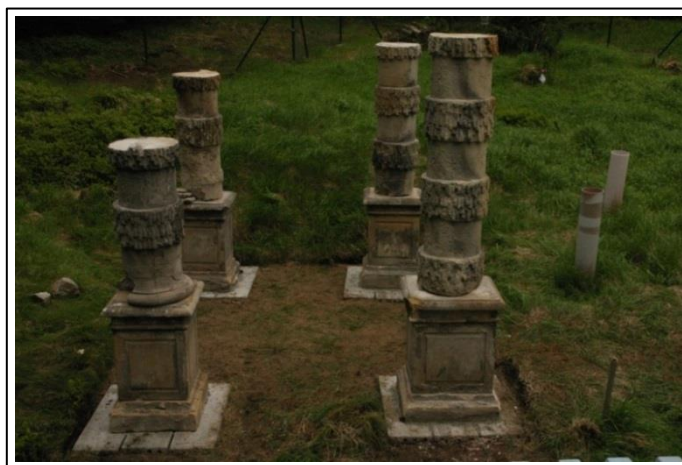
Fig. 14: Four test columns at the research station: anticlockwise starting right in front: Frühling (fabric), Sommer (light-weight), Herbst (wood) and Winter (without covering).

Three types of winter covers were constructed for and applied over trial stone sculpted columns installed at a site of a research station of the IÖZ Freiberg, Erzgebirge, to obtain measurement results from different covering options. The trial objects are reused original columns from the Zwinger in Dresden, set on aged pedestals (Fig. 14). The columns are comprised of Cotta type Elbe sandstone. Each column was equipped with climate loggers. Winter covers were applied in November and dismantled in March. One column named “Frühling” was wrapped in a procedure as developed in Moritzburg 1999 (Franzen 2011), the second “Sommer” encased in the Ciccum®, a polyurethane hard foam shell, the third gets a wooden shelter original from Barockgarten Großedlitz “Herbst” and the fourth “Winter” is not protected at all.

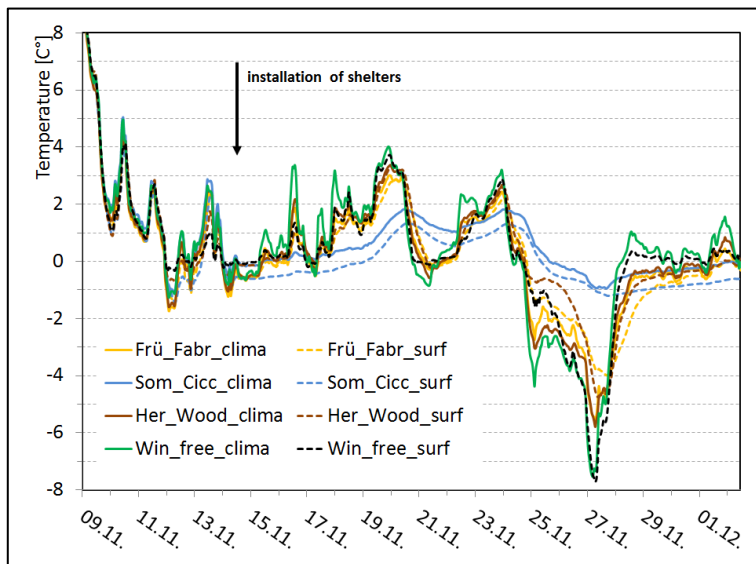
Fig. 1: Cutout of climate measurements in the field test ensemble.

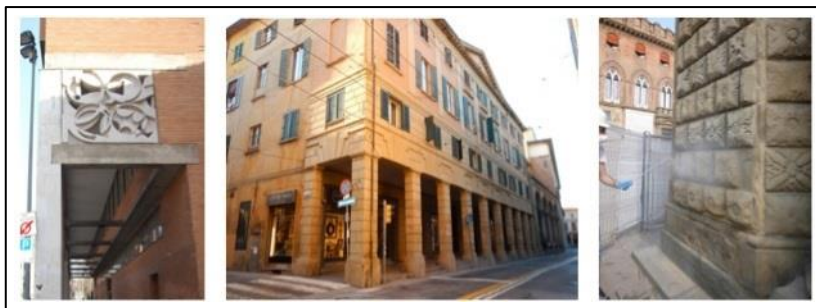
*Fig. 1: The places selected in Bologna for testing the nano-TiO<sub>2</sub> application. From left to right: the limestone sculpture in the Mathematics Dept.; the new renders of the former Del Corso Hotel; sandstone ashlars in 'Palazzo del Podestà' during the treatment application.*

This paper aims at presenting the results of some studies performed in laboratory and on-site, as a contribution to a better understanding of the aspects highlighted above. Firstly, the permanence of nano-TiO<sub>2</sub> on render and marble samples was investigated in laboratory, by subjecting the samples to an artificial rain system, in order to understand whether the nanoparticles and their photocatalytic activity are lost after exposure to rain. Then, aqueous nanodispersions of TiO<sub>2</sub> were applied to three heritage buildings in Bologna (an Istrian stone decoration of a XX Cent. building, a repair render of a XVIII Cent. portico and some sandstone ashlar of a XIII Cent. building; Fig.1) and the effects and permanence of the treatments were investigated.

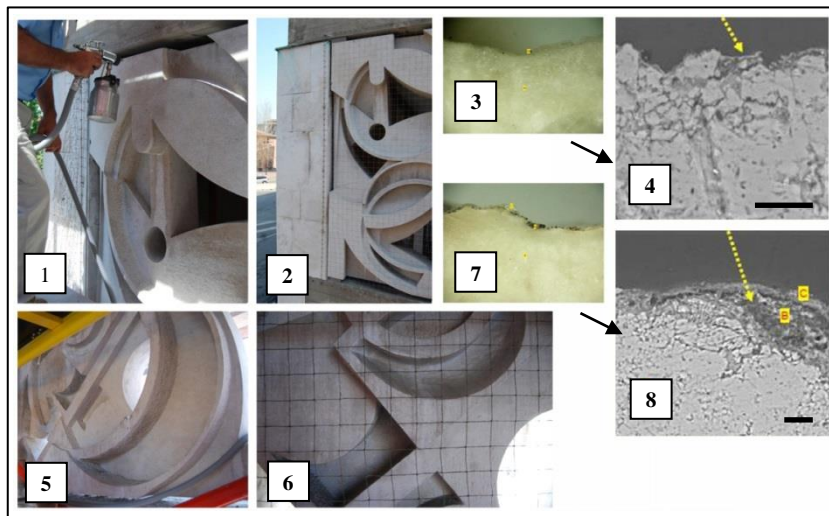
Fig. 4: External surface of the slab: 1) state at 2009; 2) state at 2012; 3) cross section observed by PLM and 4) by ESEM (marker 50  $\mu\text{m}$ ). Internal surface of the slab: 5) state at 2009; 6) state at 2012; 7) cross section observed by PLM and 8) by ESEM (marker 50  $\mu\text{m}$ ).

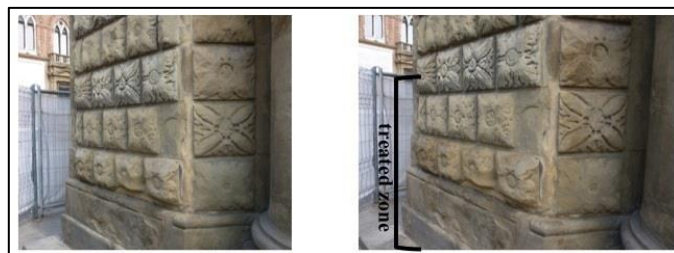
Fig. 7: The sandstone before (left) and 30' after the  $\text{TiO}_2$  application (right).

The application of a  $\text{TiO}_2$  nanodispersion identical to that used for marble samples in the laboratory tests was carried out (on 24<sup>th</sup> July 2015) in some sandstone ashlars of Palazzo Podestà, a XVI Century building which faces the central square of Bologna and is one of the most prominent monuments in the city. Despite the dark yellow colour of the stone, no visible colour change was observed after two subsequent spraying applications (Fig. 7). The monitoring of the presence of  $\text{TiO}_2$  is presently in progress.

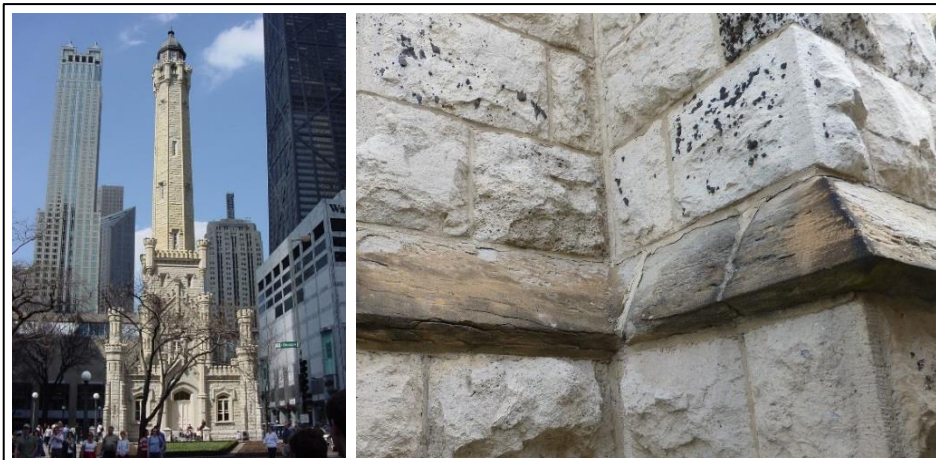
*Fig. 1: Representative example of Joliet limestone with sandstone drip course. Image on the left is of the Chicago Water Tower (1869) and the image on the right is from Second Presbyterian Church (1874) also located in Chicago. Note the asphaltic inclusions that are common in some of the limestone quarried in the area of Joliet Illinois.*

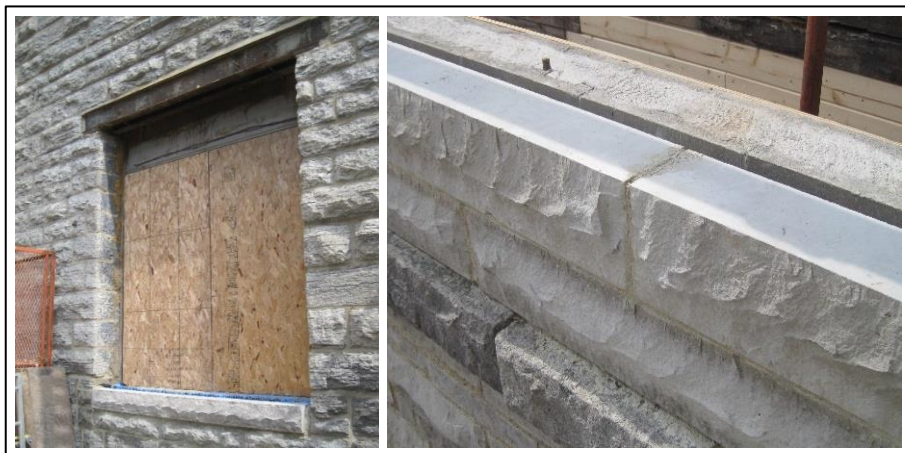
*Fig. 4: Representative examples Lannon stone used as a substitute for Platteville stone. Image on the left is a replacement sill and image on the right is a reconstruction of a parapet.*

absorption. This stone has been found to blend well with the both Joliet and Platteville limestone (Fig. 4). Indiana limestone has been found to be good substitute for Carthage marble, aside from some of the aesthetic concerns regarding uniformity described above. The material has a long successful track record of successful applications and the color is generally consistent Platteville and Carthage with the exception of the lack of pronounced bedding planes and stylolites. Using these alternate stones for water shedding façade elements as well as deteriorated façade features enable many of the buildings clad with these poor performing stones to remain in service.

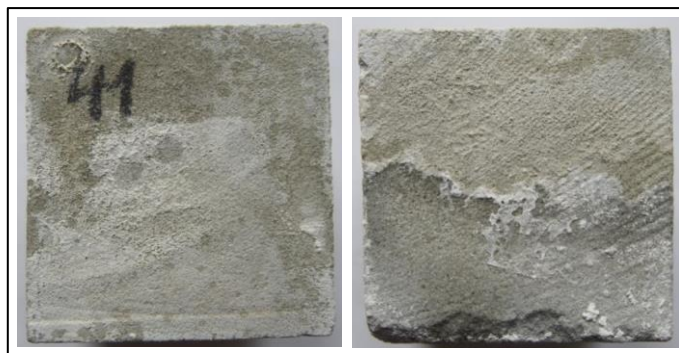
Fig. 5: White coatings after consolidation of Gotland sandstone by 15% DAP.

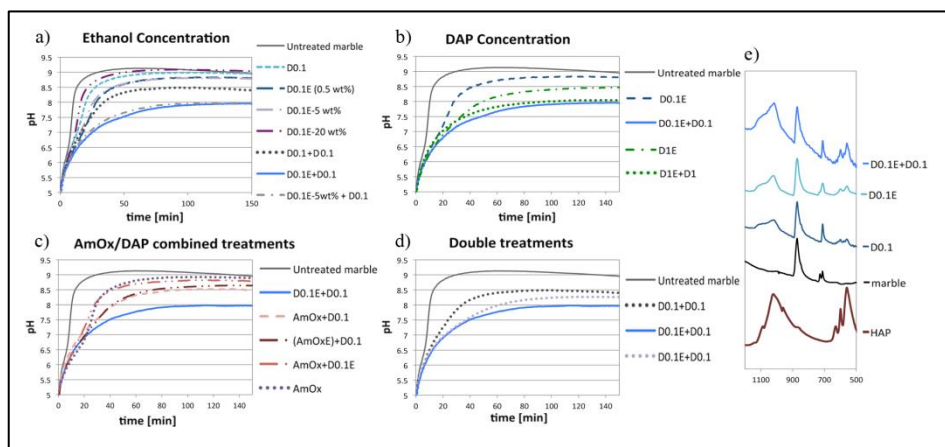
Fig. 1: Acid resistance (pH vs. time) for: a) different concentrations of ethanol in single and double treatments, b) different DAP concentrations, c) AmOx and DAP combined treatments, d) double treatments with and without ethanol addition. In e) the composition of the treated layer of the most promising formulations is investigated by FTIR.

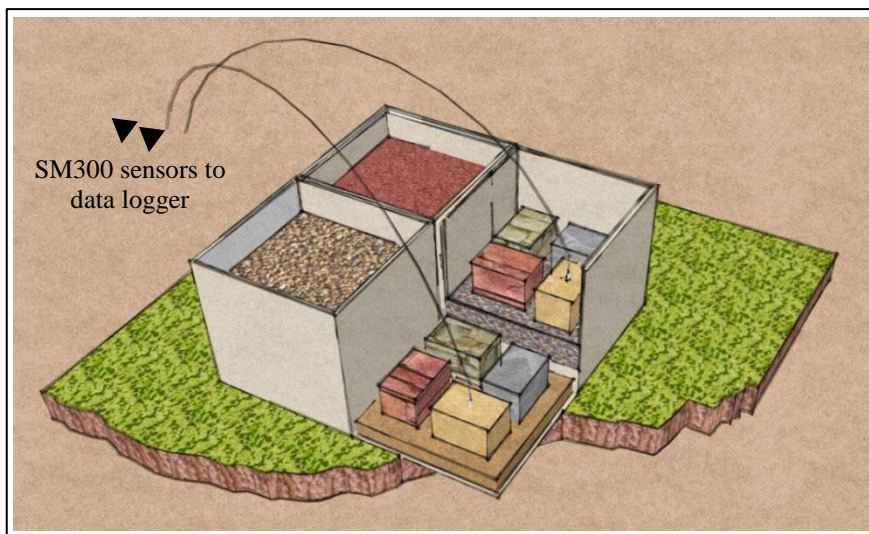
*Fig. 1: design of the trial clamps using four different burial media and four of the eight stones set at two different levels; typical positioning of the SM300 sensors is shown.*

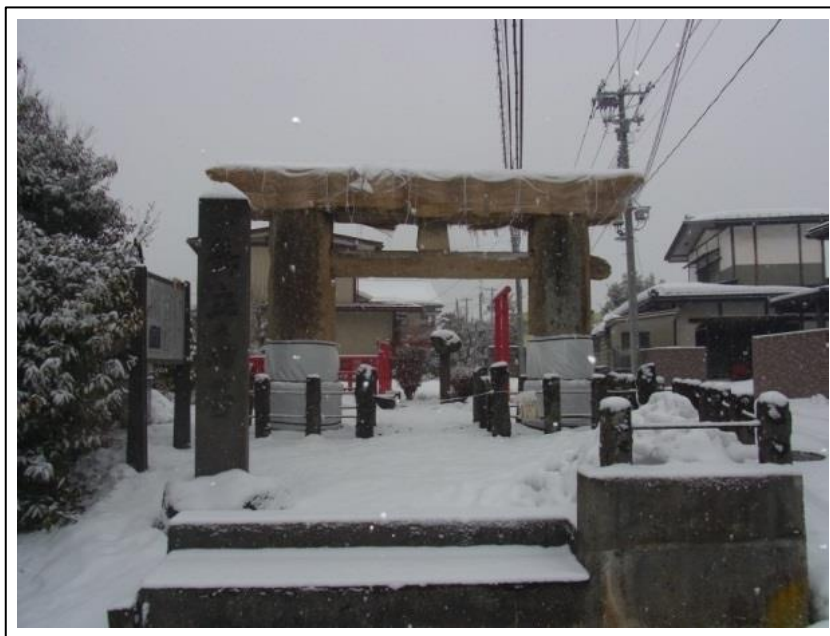
*Fig. 1: Stone shrine gate with winter cover in Motoki, Yamagata city.*

For these purposes in Germany stone monuments made of marble are covered with wood shelter during the winter season. In Japan one example of protective measures is to cover stone monuments with straw mat. Fig. 1 shows the stone shrine gate with winter cover in Motoki, Yamagata city. The stone shrine gate was built around 1000 years ago in Heian Period and it was designated as an important cultural property in Japan. The procedure for the winter cover is as follows. First the stone was covered with vinyl sheet with insulation layer, then covered with straw mat and finally covered with vinyl sheet. To evaluate the validity of this winter cover, temperatures of stone surface and cover surface were measured in winter season. The temperature and relative humidity of the environmental condition were also measured. The time lapse camera was installed to take photos of the stone gate to observe the snow accumulation on the stone gate.

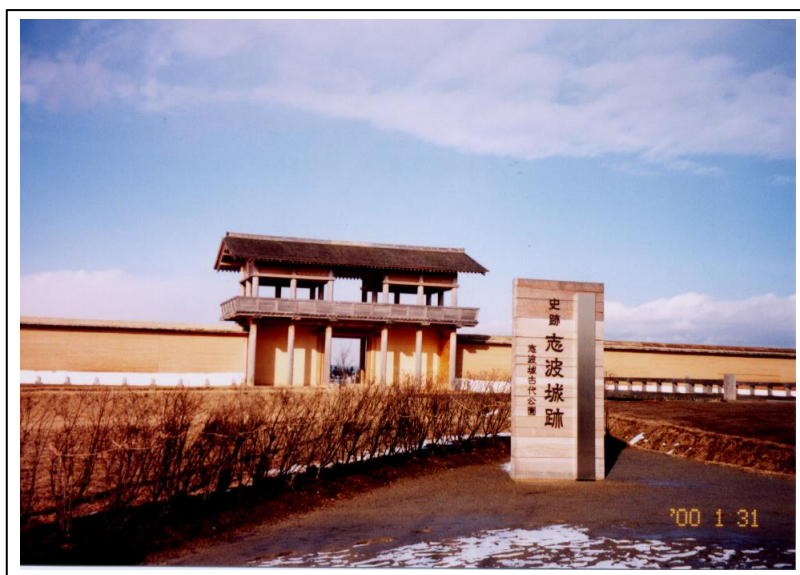
*Fig. 4: Earthen wall of Shiwa-jo in Morioka City, Iwate prefecture*

The present author has been doing research on the frost damage of earthen wall of Shiwa-jo in Morioka City, Iwate prefecture (Fig. 4). The degree of damage to the earthen wall depended on the volumetric water content of the soil. The earthen wall was damaged greatly where the volumetric water content measured by TDR (Time Domain Reflectometer) apparatus exceeded 30%. The earthen wall was not damaged where the volumetric water content was low. Laboratory experiments were carried out to clarify the relationship between the freezing temperature of the soil and the volumetric water content (Ishizaki, 2015). From these research results, it was found that the risk of frost damage becomes low if the water content of the earthen wall is kept at lower value than 20%.

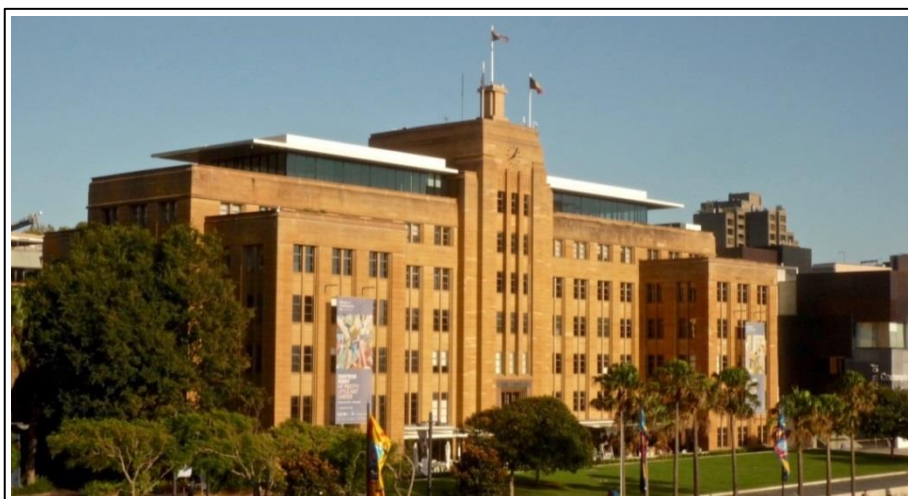
*Fig. 1: View of the east face of the Museum of Contemporary Art building, Sydney. Trials were conducted on the inside faces of the parapets of the balcony at right.*

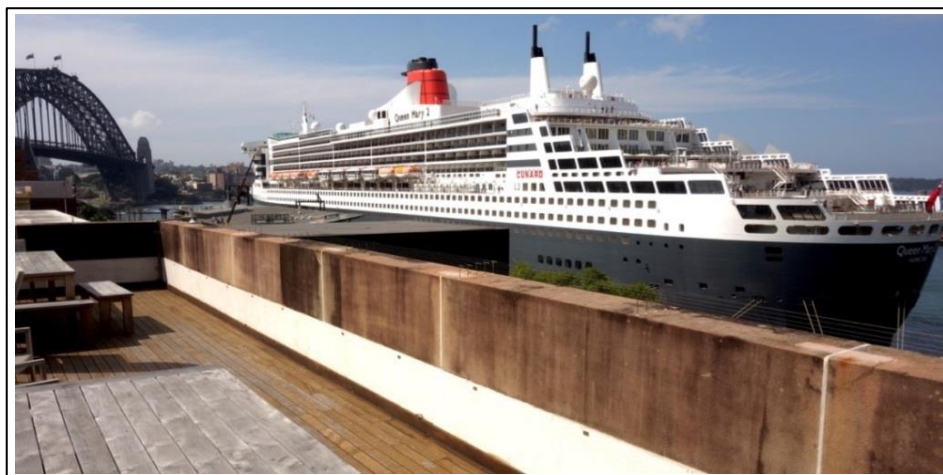
*Fig. 2: The eastern wall of the balcony, 23 months after treatment. The dark area left of centre is the untreated control panel; to its left are panels treated by poultice application of biocide. Note the wide zones around the mortar joints showing a biocidal effect of the alkaline jointing material.*

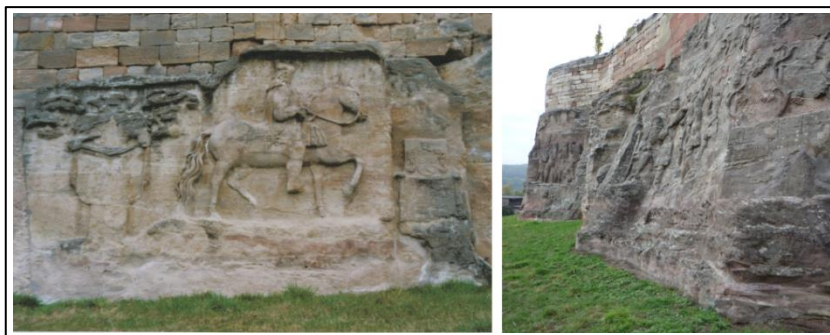
The status of the stone reliefs “Duke Christian” and “Marriage in Cana” is of particular concern. An explanation could be that the more endangered reliefs are in a completely vertical position and sheltered to some extent by a small overhang (see Fig. 2, left).

*Fig. 2: Vertical relief “Duke Christian” (left) in comparison to inclined areas (right).*

This could be associated with the fact that they stay dry longer during light showers. Thus, the salts cannot be reduced as in the case of reliefs with slight inclination (backwards) (see Fig. 2, right), which are obviously not in much danger. In both situations (vertical and inclined) the salts are already activated by a high relative humidity. But the reliefs in vertical position do not benefit from salt leaching as often as the inclined parts. Only in the case of a strong rain shower will they get completely wet. A further problem, especially in the context of recognisability, is the biological growth. The interested visitors are not allowed to get close to the Stone Album, it being located in a private section. The distance between the path and the reliefs is about 40-50 metres. Additionally to the different colours of the stone varieties, an intensive biological growth hinders the perceptibility significantly.

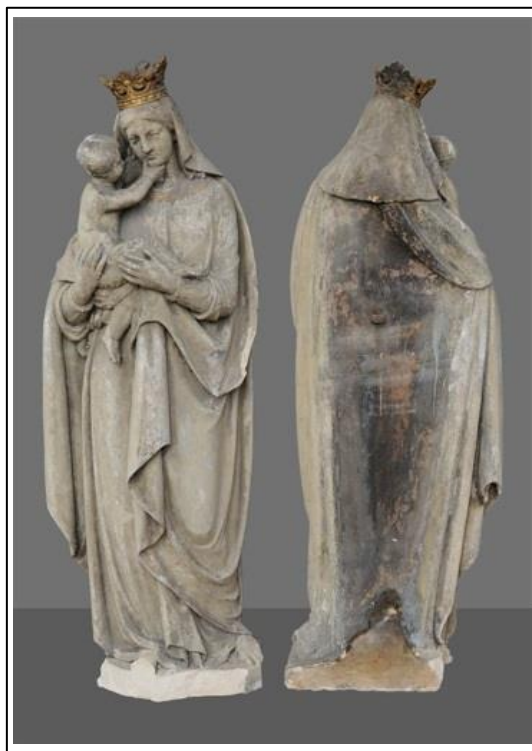
water uptake amounts to about 17% by mass. From the 14<sup>th</sup> to the late 19<sup>th</sup> century, Au Stone was probably the most appreciated Leithakalk variety for sculptural stonework in Vienna and surroundings. The sculpture is dated to the middle of the 19<sup>th</sup> century, and was produced by the Viennese sculptor Joseph Käßman (1784-1856). It was originally painted with a linseed oil based paint containing lead white as pigment, accented with some gilded sections (crown and details of the dress). The sculpture was placed on a façade in the seventh district of Vienna where it remained on site until it was first moved for conservation in 2012; earlier interventions consisted in frequent repainting, according to the fashion of the time. While most of these secondary layers are also oil bound, the most recent ones are based on acrylic emulsion as binding medium.

*Fig. 1: The sculpture of a Madonna with Child, 19<sup>th</sup> Cent., Vienna, by Joseph Käßman*

During the recent campaign, the sculpture had to be removed from the façade because of its instability and the danger of losing pieces. When delivered to the atelier, the most exposed parts such as sections from the drapery and the feet were already heavily cracked or broken in many pieces. Initial analyses by light microscopy confirmed the presence of an original paint layer. Drilling resistance showed the poor condition of the stone underneath. It was therefore decided that the sculpture had to be consolidated. Based on the drilling resistance profiles, it was obvious that a deep penetration was essential. To this end, the consolidant had to penetrate through the crazele in the oil paint layer, or find its way through the few lacunae.

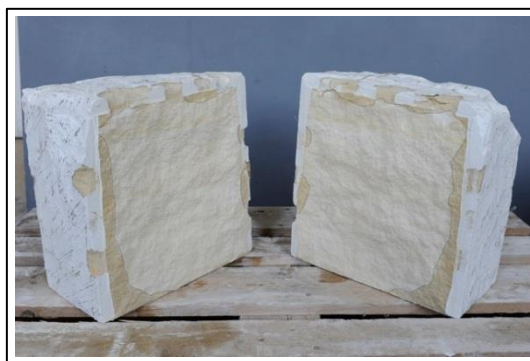
The first test results were based on the observation of the penetration depth along the split faces. The cubes that had been treated in a consolidation bath and by the VCP method, respectively, appeared fully soaked with the consolidant. On the contrary, the cube treated in the run-off test showed very low penetration depths of 0-7 cm (Fig. 2). In particular, the penetration was dependant on the condition of the paint layer in a specific area. Where the colour was scratched or lacunae were present, the consolidant could penetrate the stone fairly well. In areas with intact paint-layer the penetration depth was either very small or not determinable.

*Fig. 2: Low and irregular penetration depth of the consolidant applied to the outer faces of the cube by run-off*

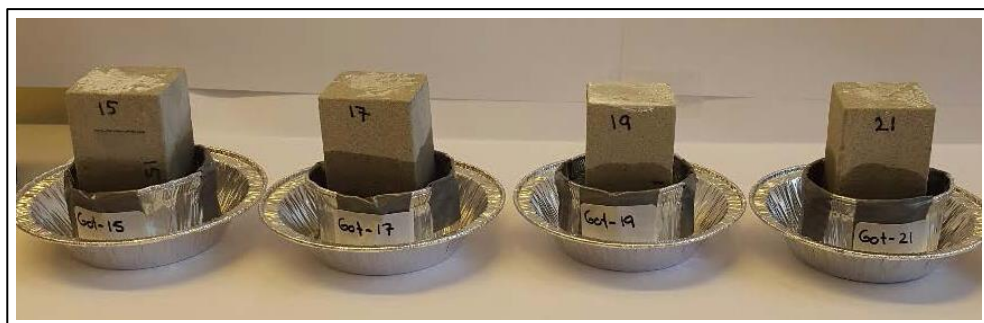
The present experimental work focuses on stone decay caused by calcium sulfate formed during ED and since this salt has a low solubility it will not necessarily be seen in the concentration profiles measured in the suspension of powdered sandstone in water. Thus it is necessary to evaluate the ED process based also on the decay pattern. Two drying/wetting cycles were performed just after ED: the stone pieces were dried to constant weight at 50°C. They were placed in distilled water to a height of 1 cm (Fig. 3). The surface where the cathode poultice had been placed was placed in the water. The water level in the beaker was kept constant manually. When water had been sucked all the way through the stone piece, the stones were left for 1 day in the setup. The stones were dried again to constant weight at 50°C and the suction procedure was repeated. After the second suction was completed, the stone pieces were inspected visually and compressive strength tests were performed.

Fig. 3: Suction test after ED.

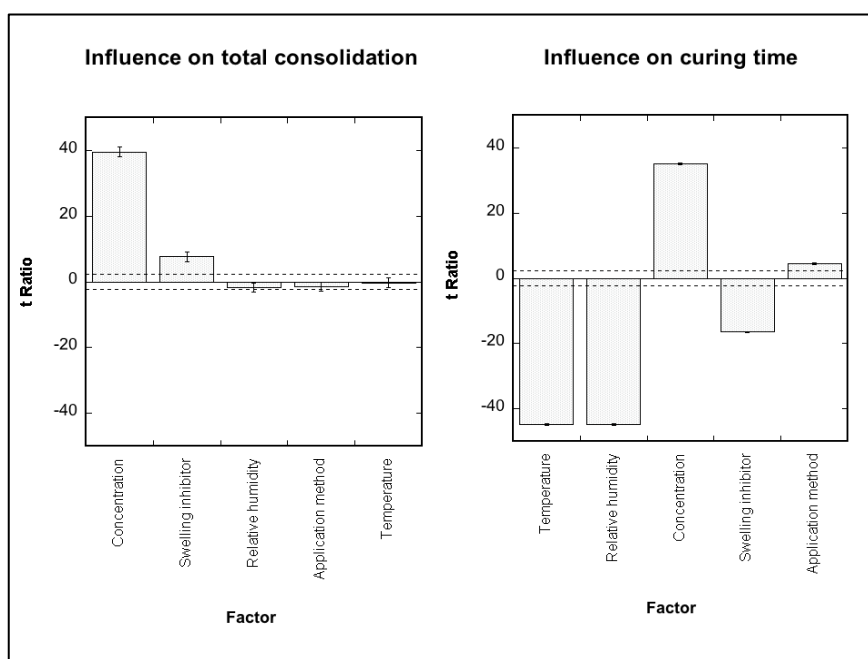
Fig. 2: *t*-Ratio plot 5 of the factors influence on the total consolidation (left) and on curing time (right). The *t*-Ratio is the ratio of the parameter estimated to its standard error and quantifies the influence of a factor. The effect of a factor is considered significant with a 95% confidence when the *t*-Ratio is higher than the critical value at 0.05 significance level (horizontal dashed line in Fig. 2). Positive numbers indicate a proportional influence of the factor on the response (i.e. higher concentration leads to a higher total consolidation), whereas negative numbers indicate a negatively proportional effect (i.e. high relative humidity decreases the curing time).
