## **SCIENCE and ART: A Future for Stone**

**Proceedings of the 13<sup>th</sup> International Congress on the  
Deterioration and Conservation of Stone – Volume II**

6<sup>th</sup> to 10<sup>th</sup> September 2016, Paisley, Scotland

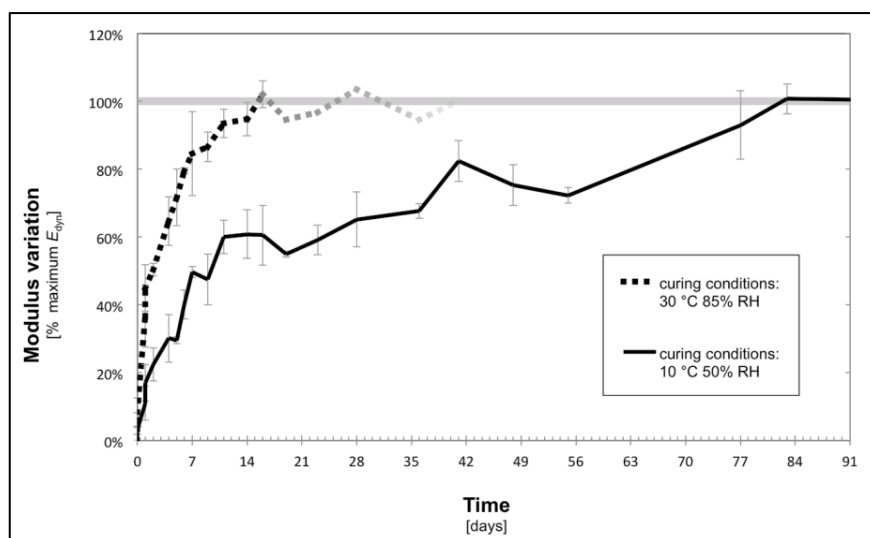
Fig. 3: Curing of samples consolidated with pure Wacker OH 100 by wet-on-wet applications, not pre-treated with swelling inhibitor. The curves are normalized to the highest total consolidation reached.

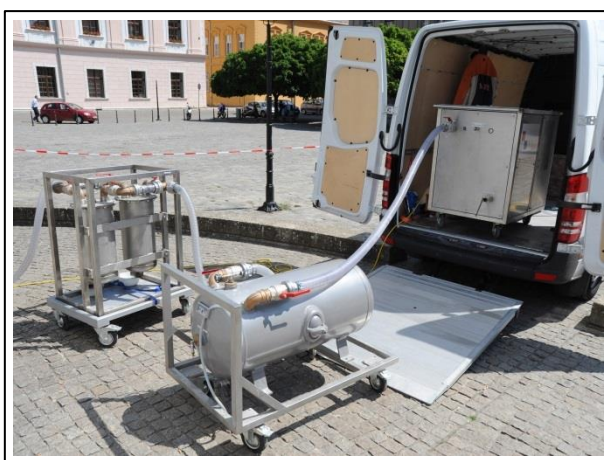
The equipment is easily moveable and offers the possibility to conserve objects in any position or situation, on buildings or freestanding (Fig. 1 and Fig. 2). The principle of VCP is shown in Fig. 2.

*Fig. 1: Mobile VCP equipment, vacuum pump (in the back of the van), balance tank (middle), tank A&B combination (left; see Fig. 2 for further details).*

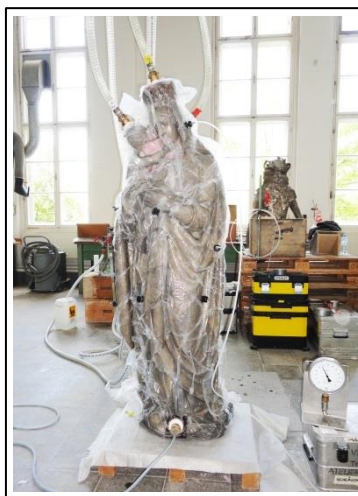
The sculpture was situated on a façade in the 7<sup>th</sup> district of Vienna. It is sculptured in a very porous calcareous Arenite with an original polychromic executed using an oil technique. The sculpture was demounted and was transported to the restoration laboratory of the University of Applied Art. The conservation and restoration of this statue are the subject of a diploma thesis with the task of strengthening the inner structure of the Madonna, which is covered by several layers of oil paint (2, see Paper for the 13<sup>th</sup> International Congress on the deterioration and Conservation of Stone 2016; M. Milchin *et al.* 2015). As a first step, the whole statue was wrapped in polypropylene fleece material (Fig. 3). This material had the function of protecting the surface of the statue but also to avoid leaking of the polyethylene foil used to create the airtight environment. On the highest points of the statue, purging valves were fixed with the foil. At the lowest position, inflow valves were mounted. A manometer for controlling the negative pressure inside the foil was also connected (Fig. 3).

Fig. 3: VCP treatment of the 160-cm-high statue.

After evacuating the air, the inflow of the strengthened medium silica acid ester (ESE) 300E/accelerated began. The negative pressure inside the foil went up to 800 mb and lasted for the whole process of 6 hours. When no more medium was absorbed by the stone the degree of saturation was reached, controlled by measuring the backflow in the circular flow. As a result, 61 kg ESE was absorbed, despite the fact that the surface of the stone was covered by oil paint up to nearly 95 percent. The deep penetration took place through the cracks and small defects in the coating and also through the uncoated base. At the end of the treatment the excess medium was extracted by the lowest inflow valve. The surface was not left with any oversaturation because the fleece had the function of blotting paper and absorbed all surplus liquid. The reaction of the accelerated ESE usually requires a temperature-dependent time of 4–6 weeks. Because of the prompt start of the reaction, the ESE neither drained out nor sunk inside the stone.

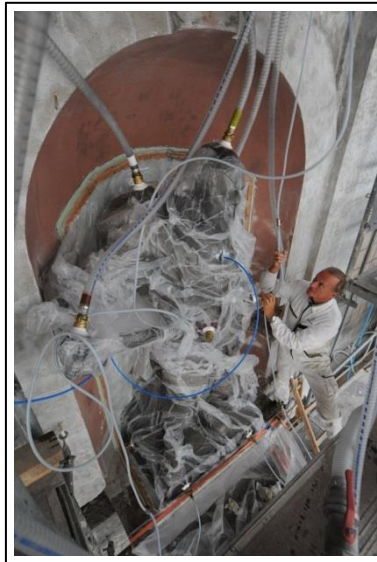
*Fig. 9: In situ VCP conservation of Duke Albrecht V; Duration of treatment: 10 hours;  
Absorption of ESE: 50 kg.*

VCP conservation was implemented on four sovereign statues made of Euville limestone. These were: Theovalda, Duke Albrecht V, Duke Wilhelm V and Emperor Maximilian I. The conservation was carried out in situ without any movement of the statues, which had a height of 250 cm. The strengthened media were ESE 300E (accelerated) and 500E (accelerated), applied in succession. Up to a depth of 10 mm the outside section is still conserved, but because of the different physical characteristics of treated and untreated stone, the outside section has lost coherence to the inner structure. Therefore the harder outside section shows spalling.

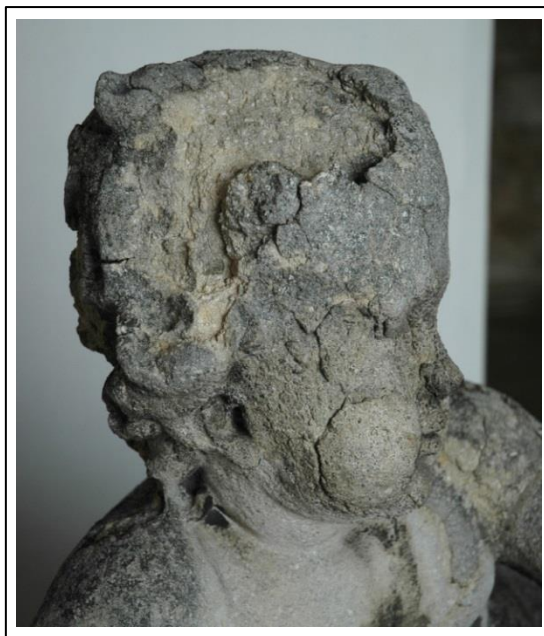
*Fig. 11: Photograph of a limestone statue surface-treated with ESE 300 20 years ago.*

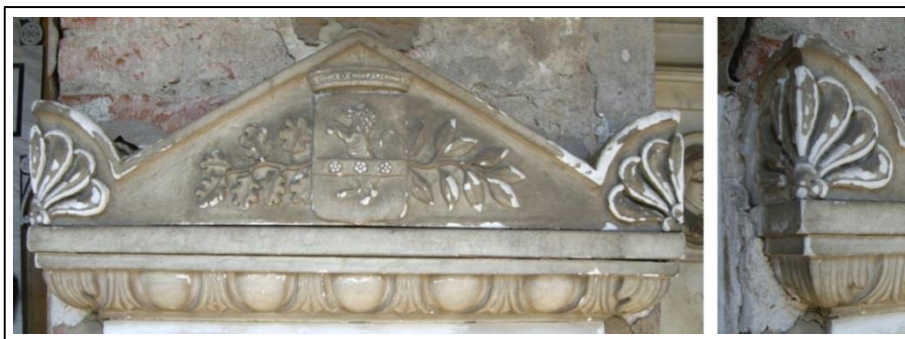
Fig. 1: Sugaring marble in the Monumental Cemetery in Bologna, Italy (XIX century).

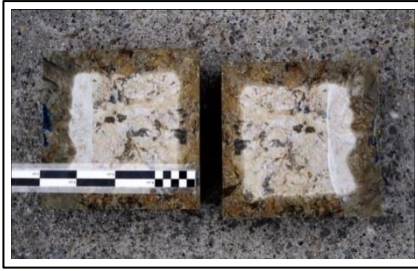
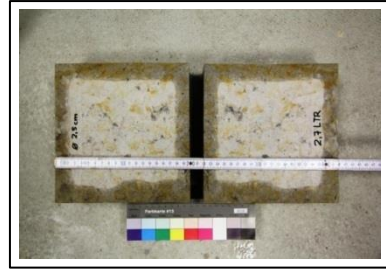
The penetration depth of the liquid consolidant was assessed by cutting two control cubes immediately after treatment with VCP and Funcosil 300E. Moreover, another test cube was cut after full immersion in Funcosil 300E under atmospheric pressure. The results are displayed in Fig. 3 and Fig. 4. They show, that the maximum penetration depths vary between 2.5 and 5 cm for two different cubes of Cotta sandstone treated with VCP under the same conditions (-200 to -500 mbar (g)) and do not differ significantly from those observed on the cube immersed in Funcosil 300E under atmospheric pressure (maximum 3 cm). As can be seen in Fig. 4 (below), penetration depth along bedding planes of the sandstone is slightly higher than normal to bedding.

*Fig. 3: Test cubes penetrated by Funcosil 300E with VCP and cut parallel to bedding immediately after the procedure (photos: E. Pummer).*

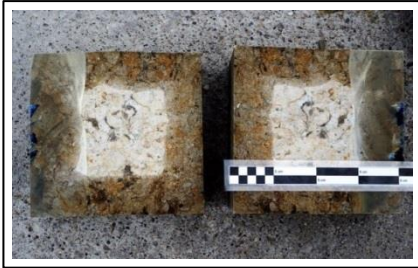
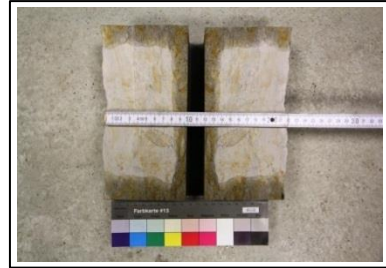
*Fig. 4: Test cube penetrated by Funcosil 300E with total immersion under atmospheric pressure and cut parallel (above) and normal to bedding (below) immediately after the procedure (photos: M. Eilenberger).*

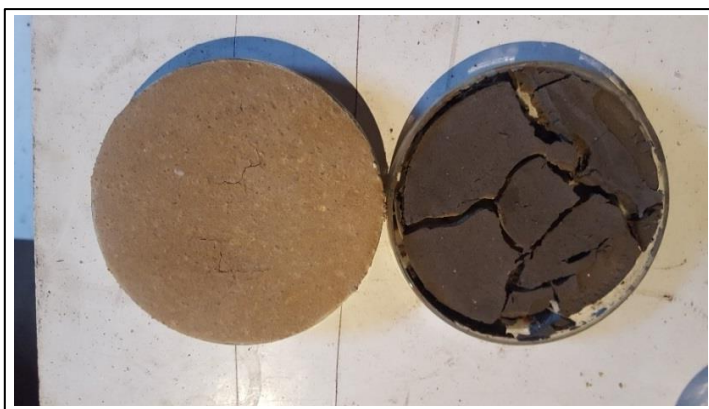
In preliminary trials mortar shrinkage was assessed by placing a coarse mix containing river sand and gravel up to 5 mm into a straight sided glass culture dish. The curing mortar expanded progressively over several weeks to finally shatter the dish. By contrast the finest filler used in the mortar formulation was a trass (pozzolanic ash) incorporated solely for colour matching purposes. The trass ranges up to 50 microns in size and when placed in the same dish displayed extensive shrinkage cracking. Fig. 1 shows both results side by side.

*Fig. 1: Two preliminary studies of the interaction between lithium silicate and silicate fillers. On the left a coarse river sand expanded to the point where the glass container was cracked. On the right a very fine Trass (pozzolana) shrank excessively.*

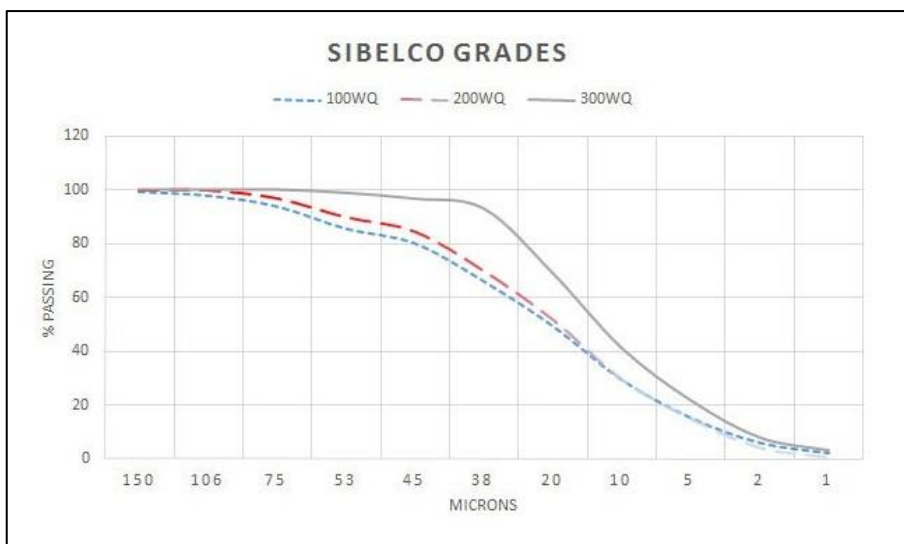
Fig. 2: Particle size distribution of the selected filler 100WQ compared to two other grades of Sibelco quartz flour.

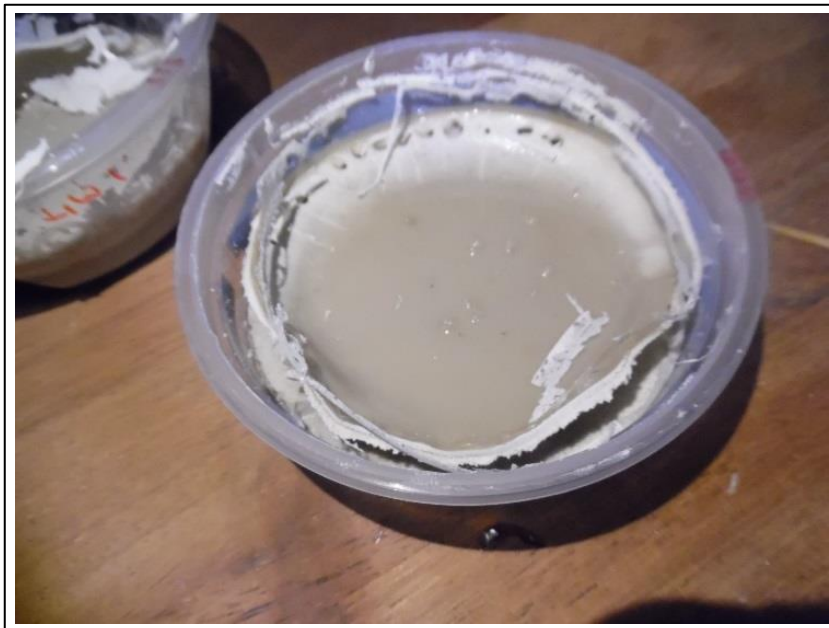
*Fig. 3: Excessive shrinkage from the 100:55 quartz flour : lithium silicate formulation when poured into an open impervious cup. This result led to the alternative test methods relying on more replicative applications to vertically oriented cavities.*

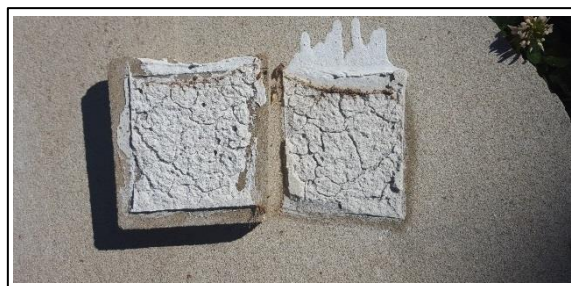
The stone on stone sample was further exposed to outdoor conditions for 45 days where it received rain, incidental watering and ambient temperatures of up to 40°C. After the 45 days the detachment was separated from the parent rock to empirically assess its bond strength and, more importantly, the consistency of the cured grout. It was seen that the grout displayed a network of shrinkage cracks not seen in the test configurations involving plastic sheet (see figure 6). There was no evidence of bleed water related transparent lithium silicate but some evidence of shrinkage to the open top surface but not away from the three enclosed sides. The test, as with all those previously described, relied on the bond strength of pure lithium silicate without the additions, previously indicated, that improve the strength and rheological properties of cured product. At this stage the research is concentrating on the performance of pure lithium silicate knowing that it can be strengthened with proven additions.

*Fig. 6: Grout applied to two sandstone surfaces remained secure for 45 days at which point it was separated. The bond was adequate but lower than ideal. The inner surface showed a network of cracks that no doubt contributed to this. The shrinkage is considered to be the result of the stone sucking liquid from the grout too quickly, emphasizing the need for adequate pre-wetting of the inner surfaces.*

The final grout was adequate for reattachment of a heavy detachment but less than achieved with the plastic sheet trials containing all of the grout with no absorption into adjacent porous material. The grout formed between two stone surfaces was also substantially weaker than lithium silicate mortars applied directly to stone surfaces. From this a couple of points of consideration emerge. The first is that wetting of the inner stone surfaces must be thorough; a critical consideration when applying grouts to closed voids. The second is that further improvement is desirable. While the lithium silicate was adequate it was not ideal. Both the addition of silica sol and especially phosphoric acid has shown a marked improvement in cohesive strength of lithium silicate mortars and these refinements will be evaluated in ongoing trials. The additive performance is already well understood from previous mortar trials and thus the transfer of knowledge presents reasonably well defined parameters.

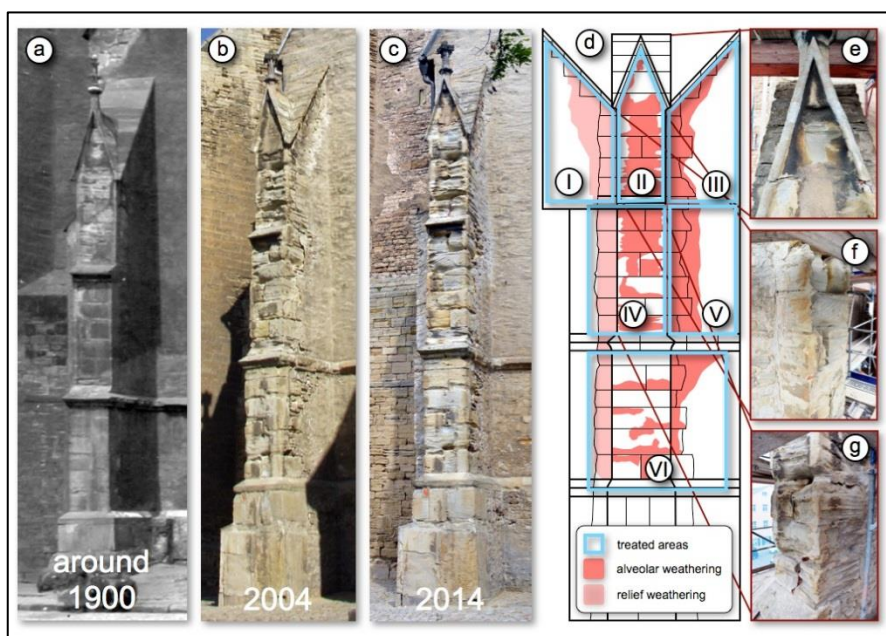
Fig. 2: a-c) The chosen pillar during different years. d) Architectural drawing with weathering conditions and treatment areas and e-g) alveolar weathering forms in detail.

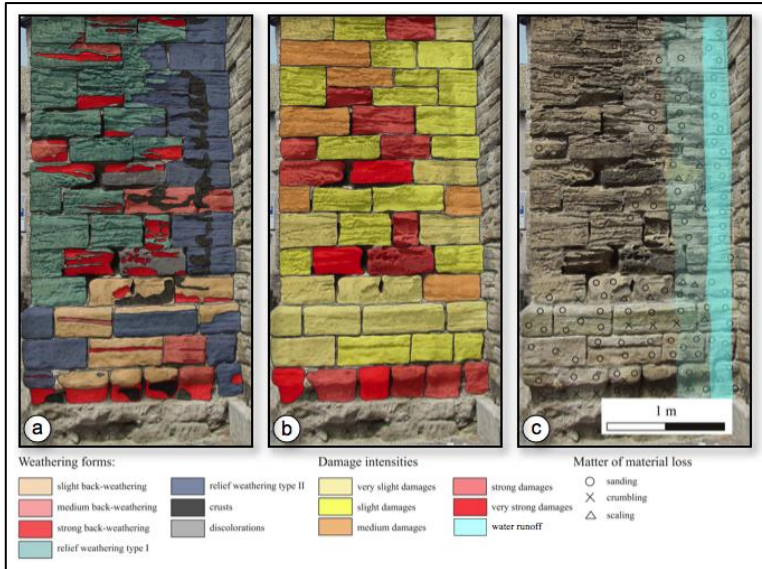
Fig. 4: a) Weathering forms, b) damage intensity and c) reasons for material loss at the testing area.

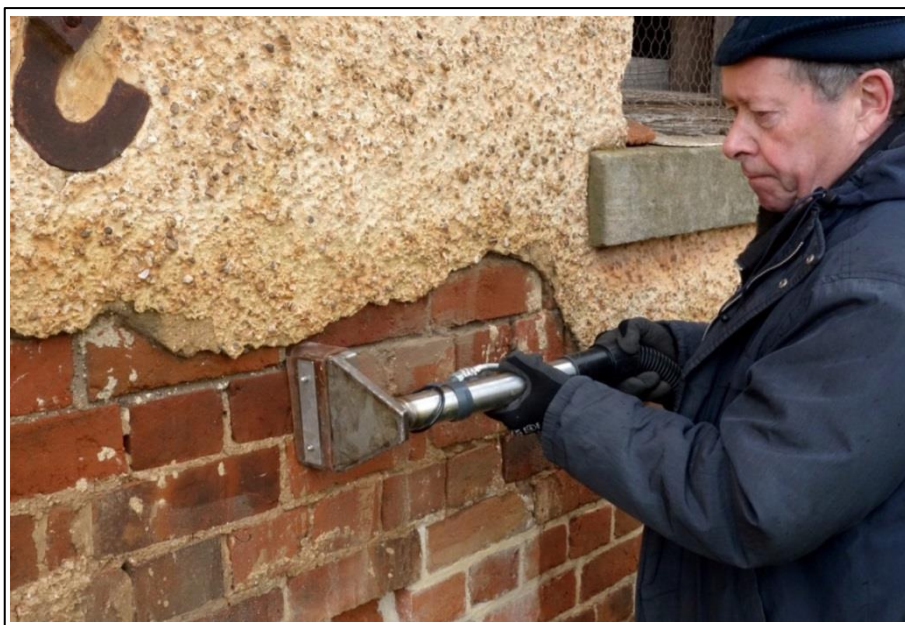
*Fig. 1: Captive-head washing system being used by Walter Heim to remove dust and dirt from brickwork prior to render repairs at Brickendon, Longford, Tasmania.*

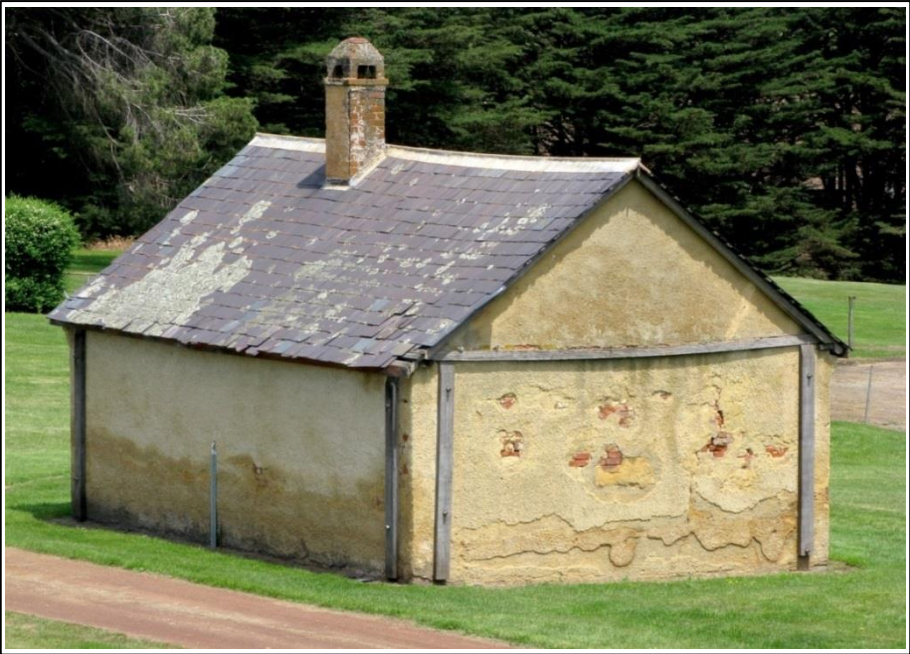
*Fig. 2: Woolmers Estate blacksmith's shop from the north. Failed rendering (harling) on the northwest wall (to the right) is allowing penetrating dampness to carry salts through the 350 mm brickwork to the interior (see Figure 3).*

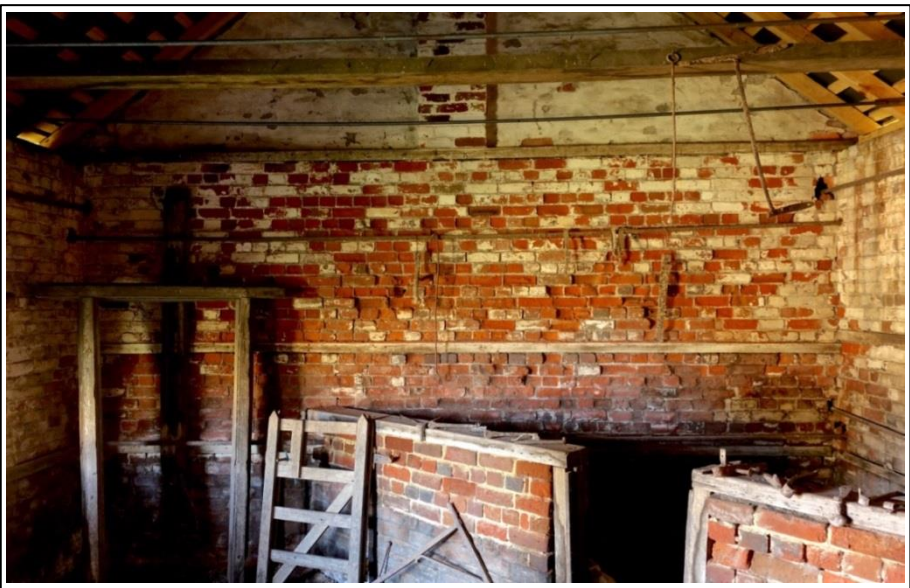
*Figure 3: Interior of northwest wall showing extensive decay of low-fired bricks due to salt attack. Early limewash finishes remain on undamaged parts of the wall.*

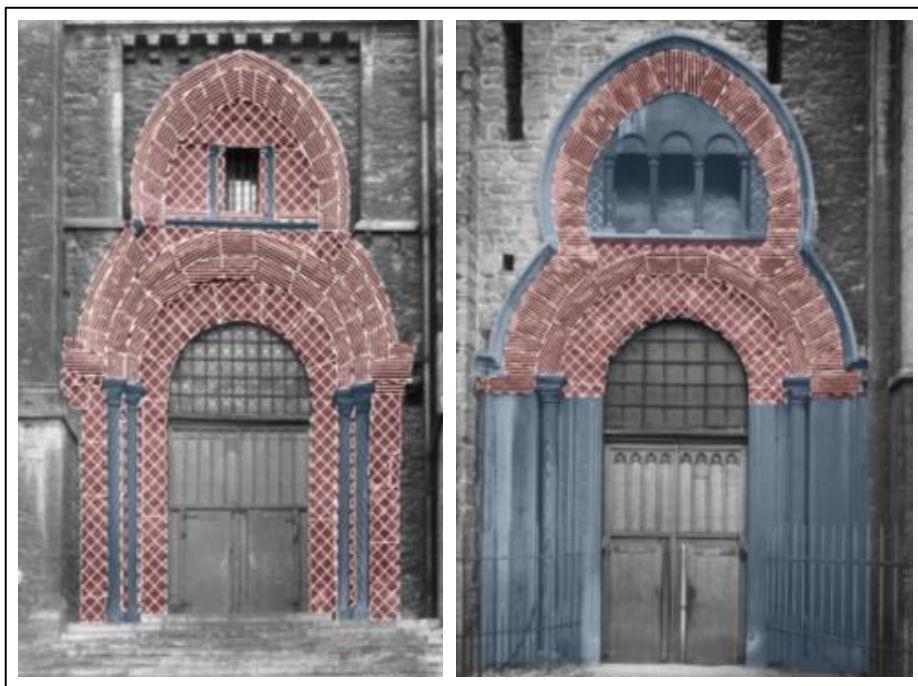
*Fig. 3: Mapping of the bedding planes of the original stone blocks in the Mantile (left) and Capitole portal (right). Hatchings underlines the bedding planes, while crosshatching is used for face-bedded blocks. Blue-coloured zones correspond to the 19th century restoration with Belgian bluestone ©KIK-IRPA, Brussels.*

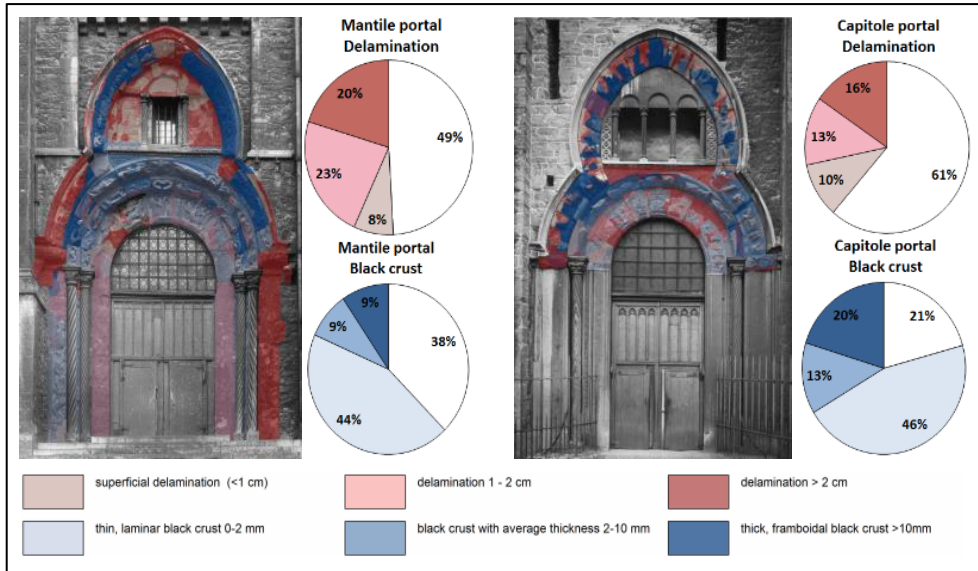
Fig. 4: Mappings and diagrams of the delamination and black crusts on the Mantile (left) and Capitoile portal (right) © KIK-IRPA, Brussels.

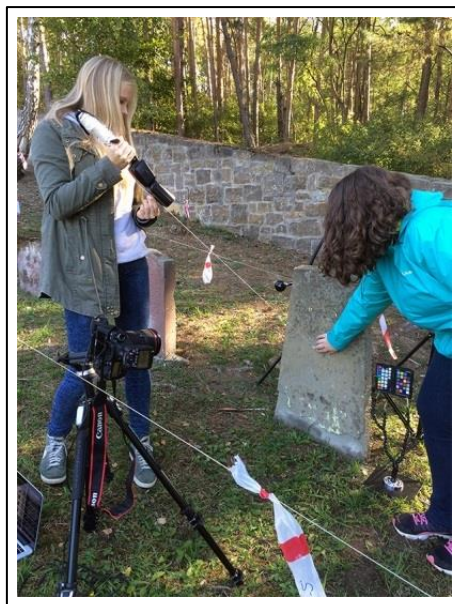
These factors allowed for creativity in problem solving during RTI acquisitions using the highlight method (Duffy 2013). For this method of imaging, the team used a standard DSLR camera and synched flash. The flash was manually situated at equidistant locations and moved between shots in an arc around the surface of the inscription, creating a virtual umbrella of light around the face of the gravestone. A string was affixed to the flash to ensure the distance of the flash to the center of the inscription remained consistent for all images. Team members were assigned distinctive responsibilities – orientation of flash, maintenance of consistent distance, and remote camera control via computer (Fig. 1).

*Fig. 1: A group prepares to capture a photograph of a gravestone in the Jewish cemetery in Unsleben in an RTI sequence using the highlight method.*

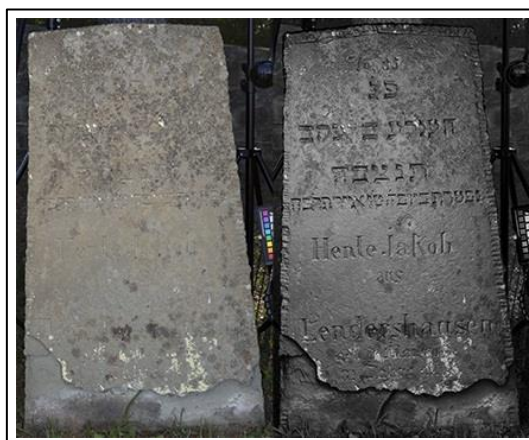
*Fig. 3: A side-by-side comparison of a standard image (left) and a snapshot of an enhanced RTI visualization (right) of an inscription on a gravestone in the Jewish cemetery in Unsleben.*

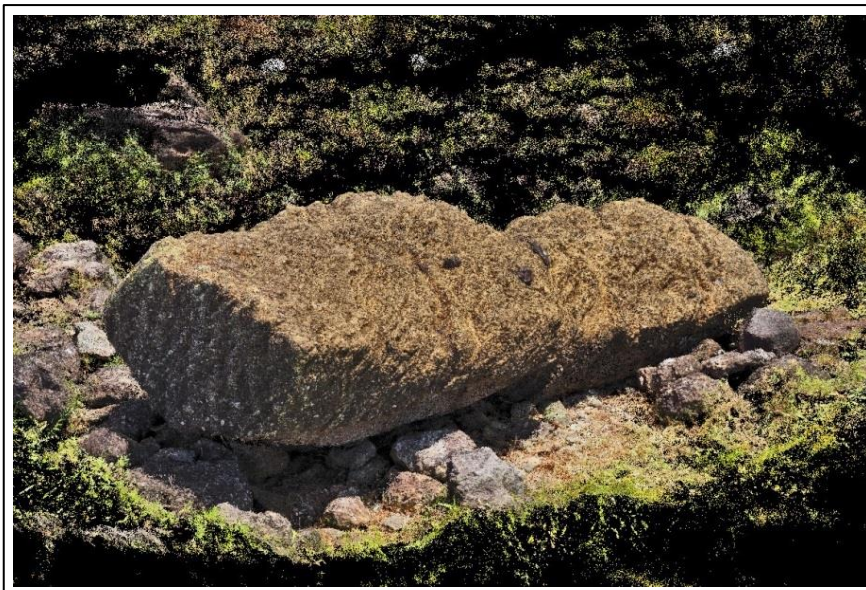
*Fig. 2: 3D point cloud: Moai of Ahu Hanua Nua Mea lies facedown, with surroundings.*

Almost all of the Moai stone sculpture which are presently found on the Island were carved from the Rano Raraku lapilli tuff. Most of them were built by using a Tuff outcropping in the southern part of the Rano Raraku volcano, where ancient quarries are still visible. From the volcano, hundreds of Moai were obtained and erected on the Island. Also, the object of this research: Moai of Ahu Hanua Nua Mea was carved quite likely from Rano Raraku lapilli tuff.

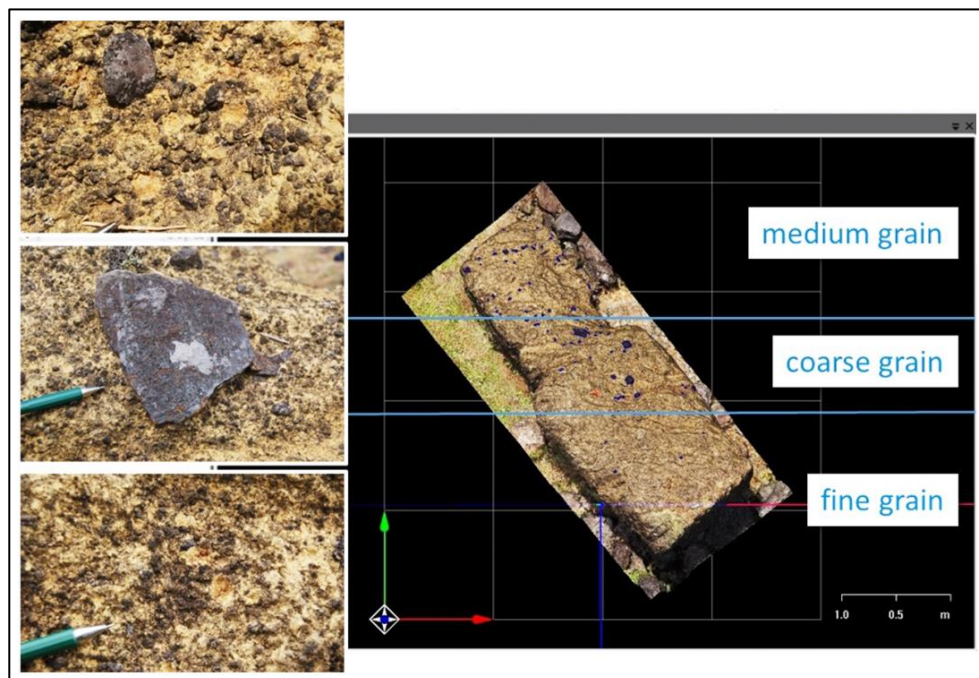
Fig. 3: Differences in the composition of the individual layers

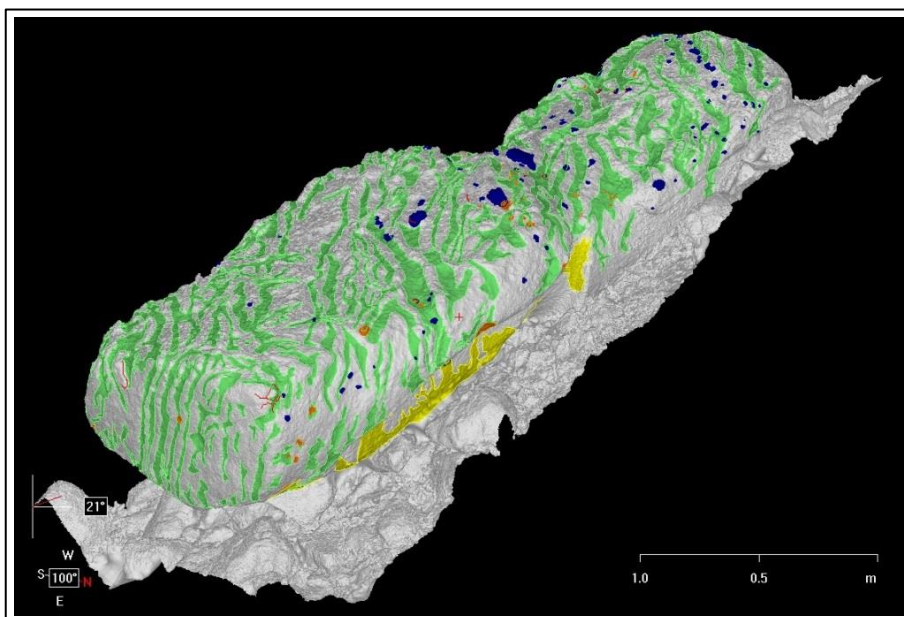
Fig. 4: 3D monument damage mapping. Surface of object is rendered shaded.

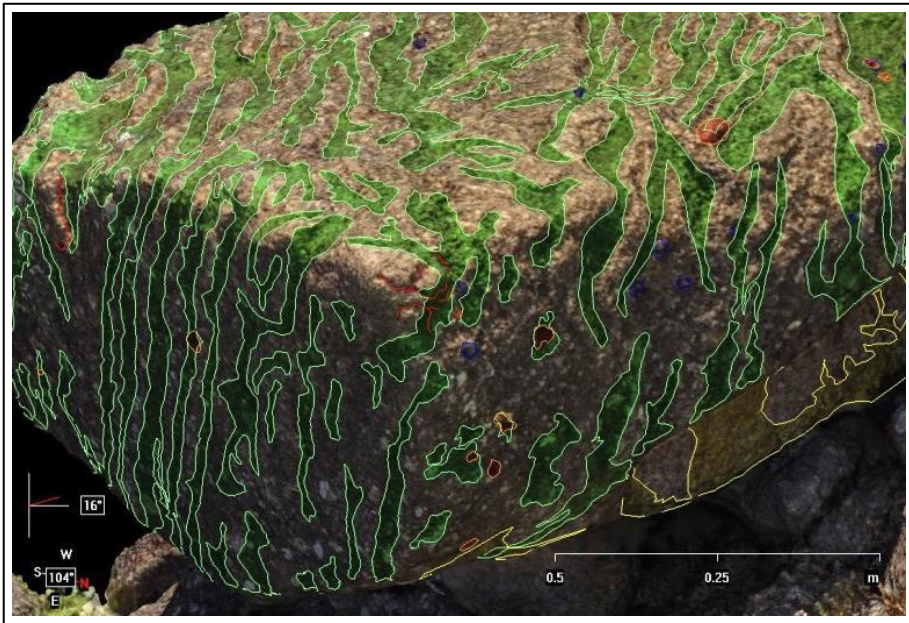
Fig. 5: 3D monument damage mapping detail: Differential erosion and cracks.

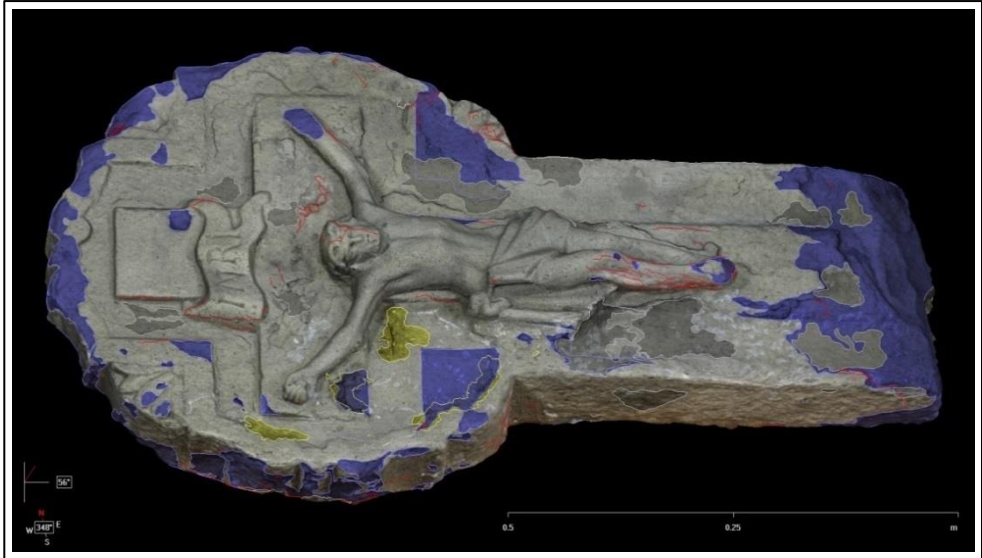
*Fig. 6: 3D monument damage mapping of late baroque tombstone: All recorded damage.*

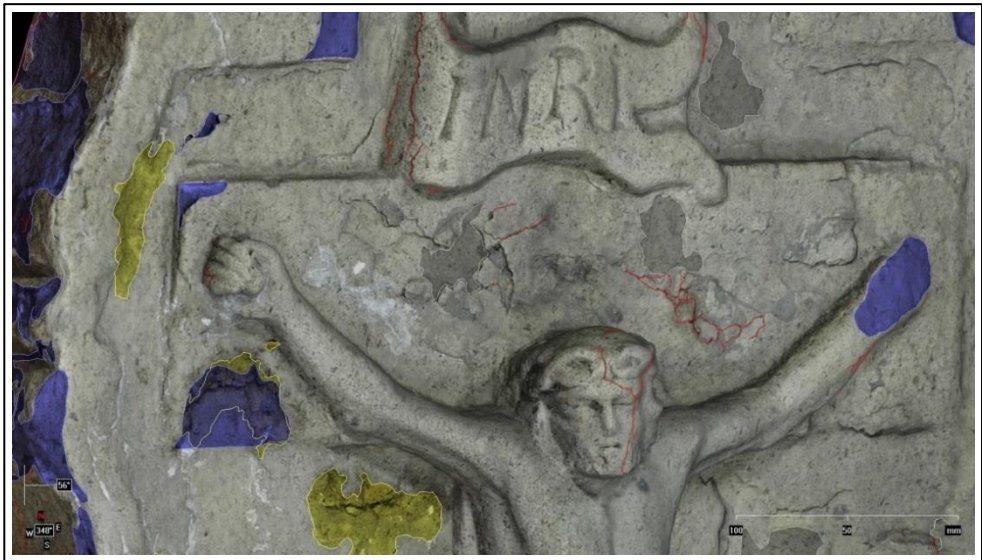
*Fig. 7: 3D monument damage mapping of late baroque tombstone: Detail.*

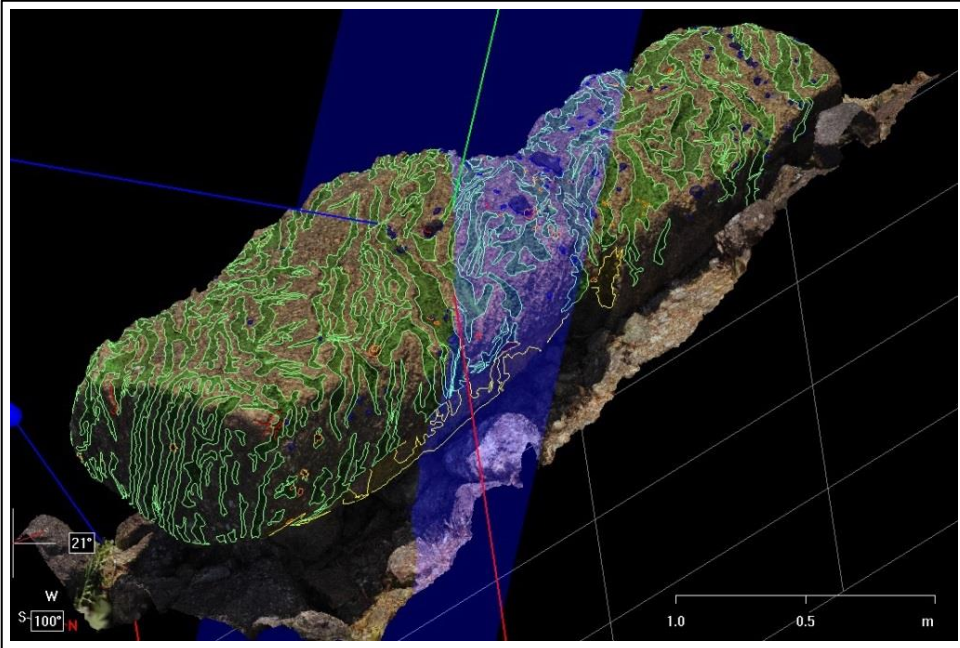
*Fig. 8: 3D monument damage mapping: differences in the composition of the individual layers*

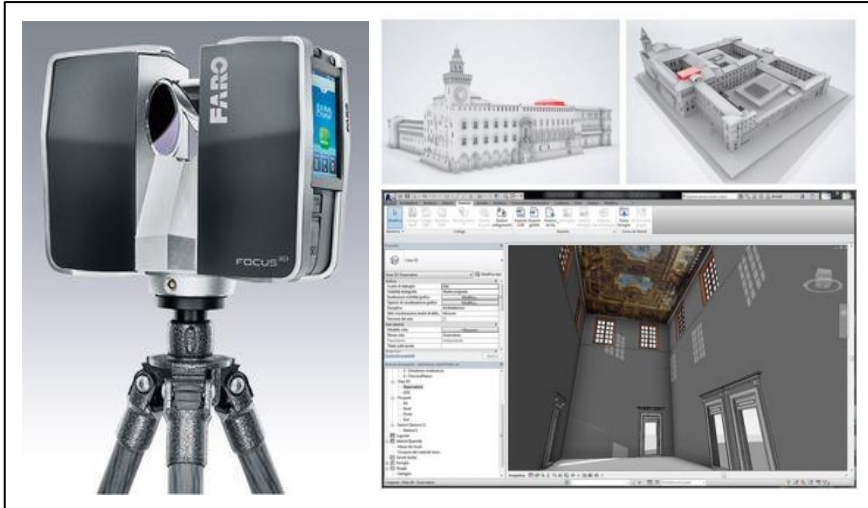
Fig. 1: 3D Laser Scanner and Historic Building Information Modelling (HBIM).

Clearly, there is a significant gap between current training provision and industry requirements. As such, there is a need for the provision of an up to date technical handbook for the R&M of historic buildings to meet current/future quality and performance standards and thereby attempting to address the current gaps in training provision (McGibbon and Abdel-Wahab, 2014). Moreover, adopting new technologies and innovative practice to historic building R&M throughout a project lifecycle (from planning to completion), will be fundamental to repair specification to inform practice and generate viable method statements for on-site operations. Therefore, the aim of this paper is to examine the current digitisation trends in the R&M of historic buildings by showcasing exemplar projects and along with its potential impact on the training provision and practice of stonemasonry. Digitisation refers to the process of converting information into a digital format which enables capturing an accurate record of the current condition of a historic building. COTAC (2014) suggested that digitisation could enhance work prioritisation, project scheduling/programming and monitoring work progress. Digitisation technologies includes: Terrestrial Laser Scanning (TLS) and Historic Building Information Modelling (HBIM) (Fig. 1) – which are subsequently discussed.

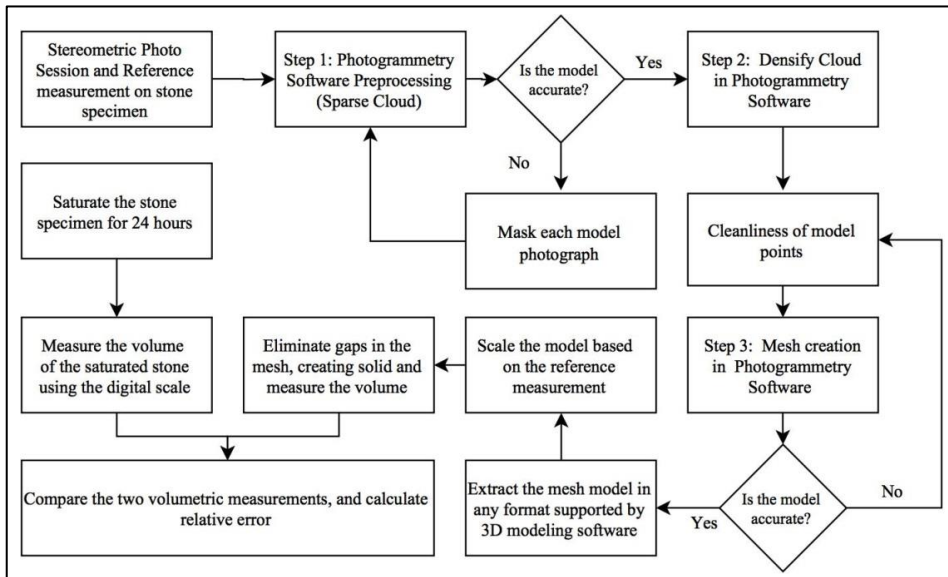
Fig. 2: Flowchart demonstrating the volumetric measurement processes for each deteriorating cycle.

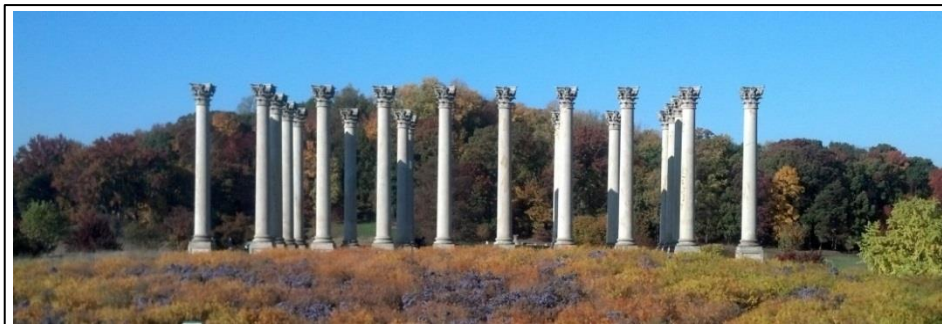
*Fig. 1: Twenty-two Aquia Creek Sandstone columns from the U.S. Capitol are seen here at their present location in the National Arboretum in Washington D.C.*

The columns are in remarkably good condition considering their nearly 200-year exposure since quarrying on an island in Virginia and placement on the east portico of the U.S. Capitol (1826 to 1958), storage at two locations for 27 years and re-erection at the Arboretum in 1988. Evidence of repairs from their initial carving and their time on the Capitol Building can still be found on the columns. Examples include patching material found to contain white lead and paint remnants in the decorative crevices of the capitals. The columns were regularly painted white, and in 2001 a study by Blythe McCarthy and William Ginell identified 16 layers of paint on them. Gouges also remain where a railing was attached between pedestals on the Capitol building.

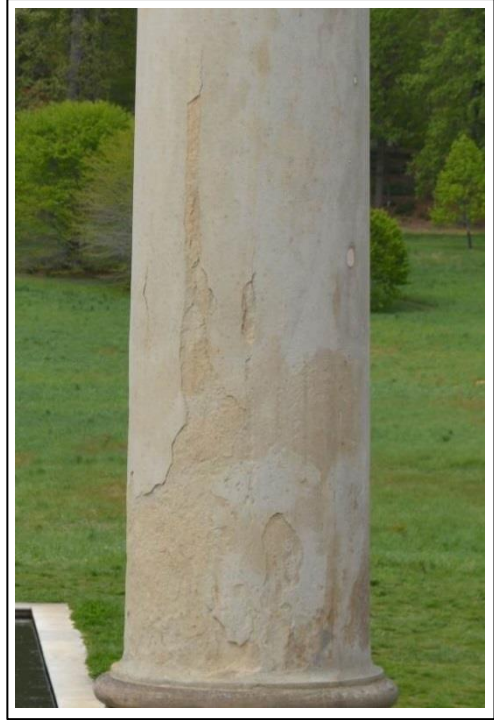
*Fig. 4: The lower shaft of column L20 has the highest contour loss, extending more than six feet; a detached area reaches even higher. The area of detachment can be seen on the left.*

Washington D.C. has a humid, subtropical climate with multiple wet/dry and freeze/thaw cycles that would continually stress weaker areas, eventually leading to contour loss, although the exact driving mechanism remains a matter of discussion. Detachment was likely occurring early in the columns' existence while still on the U.S. Capitol or in subsequent storage, since significant contour losses were documented by the architectural firm Oehrlein and Associates just before the columns were erected in the Arboretum (EDAWinc. *et al.* 1987, A2-A7). The earliest photographs that could be obtained showing contour losses were taken by the second author in 1988: comparison to current condition suggests about 10-15% additional loss over the 25 years since then (Fig. 5 and Fig. 6).

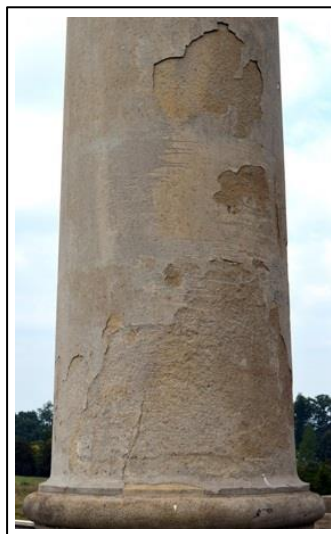
*Fig. 6: Same location as the previous in 2013, showing an estimated 10-15% additional contour losses after 25 years.*

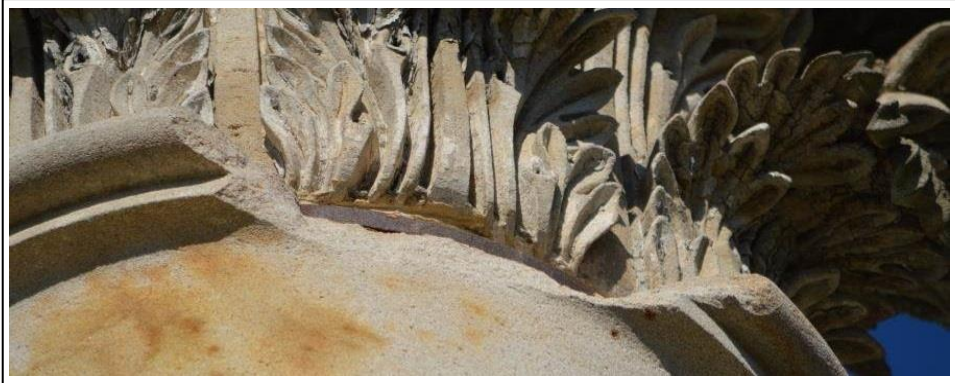
*Fig. 7: Detail of stone loss from L13's astragal, revealing its iron ring directly below the bottom edge of the capital.*

The astragals present the most complex and difficult problems for the columns, since the lead-bedded iron rings set into the top of column shafts are covered by the capitals. The only means of completely halting deterioration would be to remove the rings. This would be nearly impossible to do without harming the stone, since the capitals are fixed to the shafts with epoxied steel dowels and mortar. In lieu of removal, a method to slow water entry is required such as flashing to top surface of the astragals.

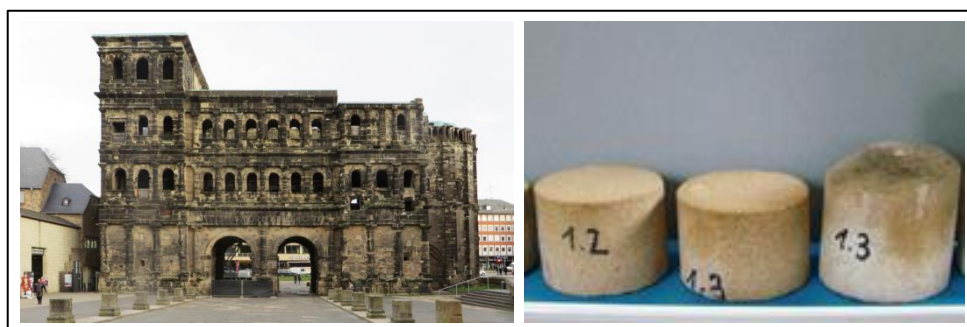
Fig. 1: The Porta Nigra in Trier and drill cores showing brown discolouration after testing for capillary water absorption.

The types A, C, and D are characterized by the enrichment of Fe-(hydr-)oxides on the stone surface. Drill cores taken from a weathered sandstone block with a slightly discoloured surface (Type A-B) displayed an intensive brownish discolouration after testing the capillary water adsorption and subsequent drying (Fig. 1, right). This indicates that the enrichment is mainly due to the mobilization of some compounds in the interior of stone and their transport to the surface with pore fluids.

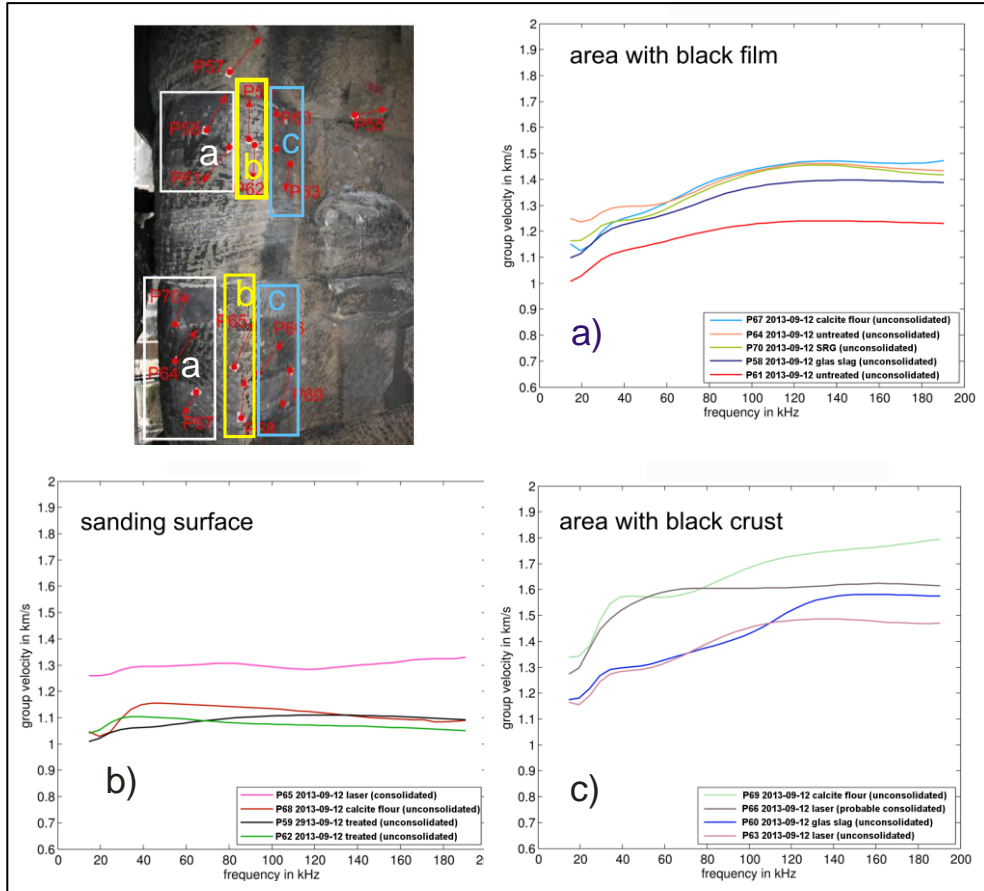
Fig. 3: Rayleigh waves showing an increase or decrease of velocity with increasing frequency (Meier 2016).

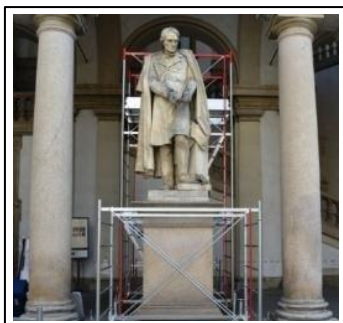
*Fig. 2: Initial phases of the conservation of Antonio Galli's sculpture of Carlo Ottavio Castiglione (1855). Height of statue plus the pedestal 503 cm (198 inches), Just the statue 305 cm (120 inches). The original surface appears hidden by a layer of aged protective varnish.*

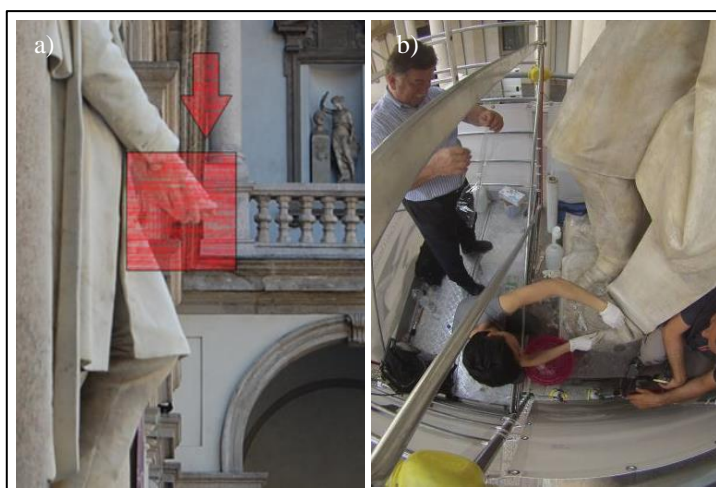
Fig. 7: a) Scheme of the consolidation system adopted (dip coating); b) Dr. Annalisa Balloi during the application of sulfate-reducing bacteria through a gelatinous medium on the areas that were altered and covered by sulfates.

With the help of Dr. Annalisa Balloi sulfate-reducing bacteria through a gelatinous medium were applied on sulfated areas that appeared altered. The gelatinous medium was left overnight on the stone surface until the desired result where obtained. The bacteria contained in the gel attack and eliminate the sulfate. Local interventions of traditional cleaning were limited to the removal of varnish drops that had fallen from above. These interventions have been performed by swabbing soluble non-polar solvents. The conservation intervention was then concluded with a mild application (4% micro-dispersed acrylic in water) with a protective patina on all the surfaces, to reduce the absorption of meteoric and condensation water (albeit for a limited time).

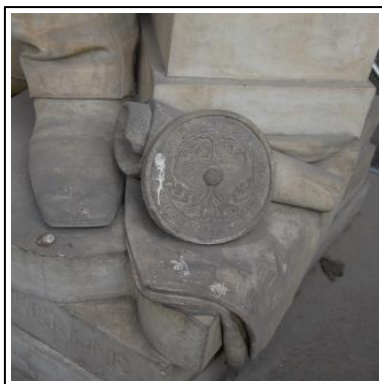
*Fig. 8: Signature of Antonio Galli on the statue of Carlo Ottavio Castiglione (1855) before the application of sulfate-reducing bacteria by a gelatinous medium.*

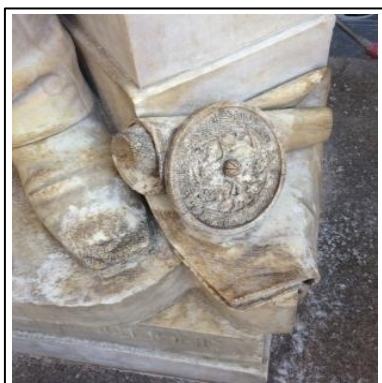
*Fig. 9: Signature of Carlo Ottavio Castiglione's statue (1855) during the cleaning using sulfate-reducing bacteria applied to the surface with the aid of a gelatinous medium. The cleaning has brought to light (for example in the right area of the cartouche) some punctual spots along the surface. FTIR analysis carried out by Palladio Analisi s.r.l. laboratories identified calcium carbonate, gypsum, silicates, and very feeble traces fluorosilicate absorptions, which are most probably left by residues of protective and polishing products used in the past.*

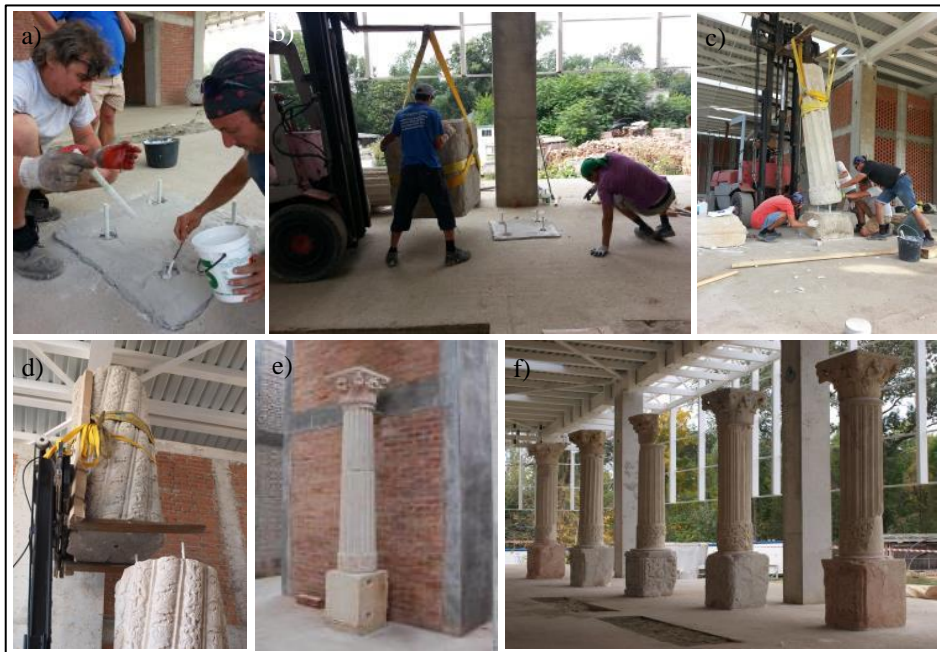
*Fig. 5: Installation of the columns: a and b) Bottom pin structure, c to e) Assembly of the decorated stone block to columns in the Royal House; f) Columns of the veranda.*

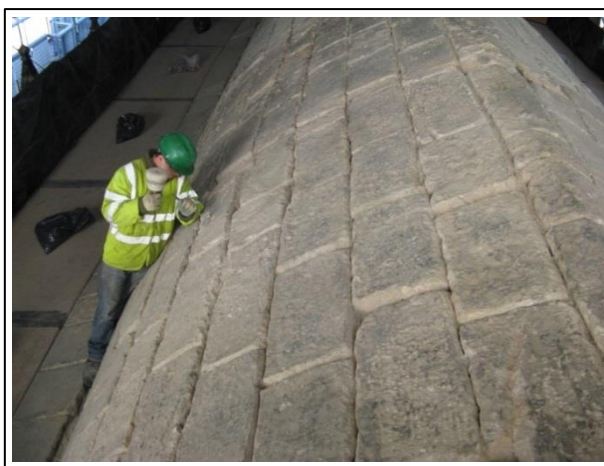
*Fig. 1: Raking out vault joints.*

Significant portions of the chapel's construction joints had been repointed with OPC mortar during an earlier intervention. OPC is harder and less breathable than traditional lime mortar, causing sacrificial erosion of the surrounding stone as it deteriorates due to the excess moisture. Because of this, it was important to remove all OPC from the joints at Rosslyn Chapel and re-point them with traditional lime mortar. All construction joints identified as requiring re-pointing were carefully raked out using sharp tungsten tipped chisels and mallets to a sufficient depth to accept lime mortar repair (*Fig. 1*). Any loose material within the joint that could decrease the adhesion of the mortar was removed in a scooping action using a tool of appropriate width to ensure no marking of the dressed stone surface occurred. The joints were next washed out with water to remove any remaining debris or dust.
