## **SCIENCE and ART: A Future for Stone**

**Proceedings of the 13<sup>th</sup> International Congress on the  
Deterioration and Conservation of Stone – Volume II**

6<sup>th</sup> to 10<sup>th</sup> September 2016, Paisley, Scotland

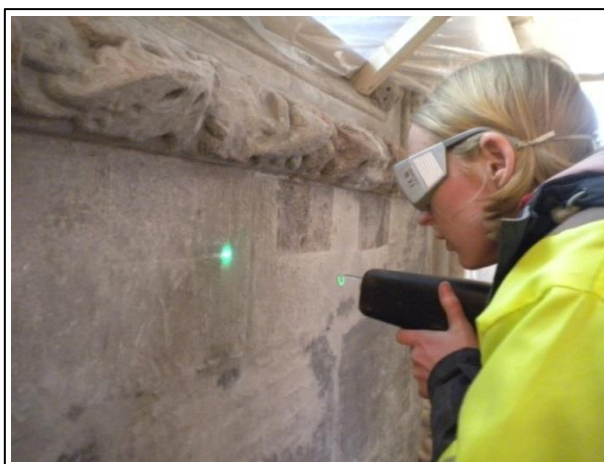
*Fig. 3: Desoiling using Nd:Yag Conservation Laser System.*

The Nd:Yag Conservation Laser was employed throughout this project to reduce the level of environmental pollution products affecting the Rosslyn Chapel stonework (*Fig. 3*). The level of soiling to be removed was determined after much discussion and a number of trial areas. Soiling was initially identified as heavy, medium and light, and a distinction was made between soiling visibly causing 'preferential erosion,' or the visible accelerated decay of adjacent stonework, and that causing no apparent immediate harm.

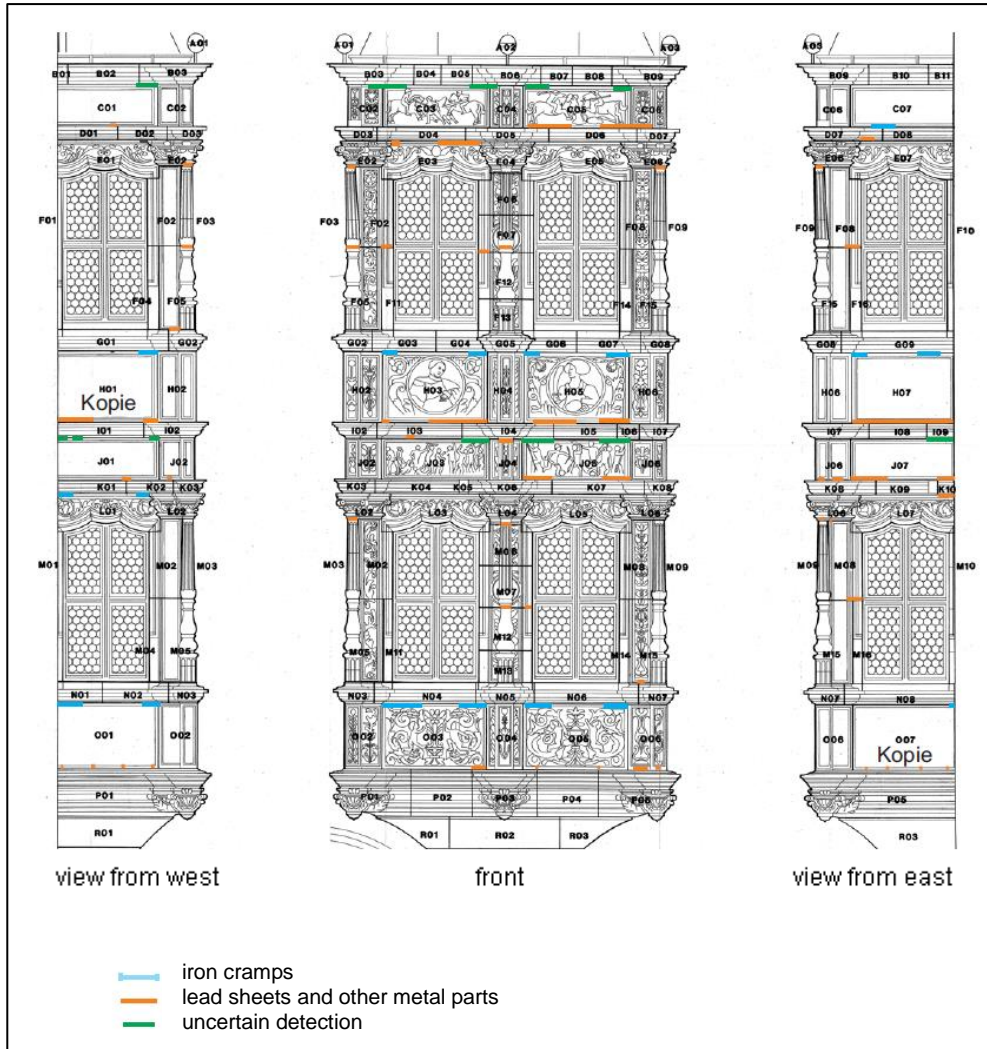
Fig. 2: Distribution of iron cramps and anchors shown on a base plan which identifies all stone pieces. "Kopie" indicates pieces replaced in 1928.

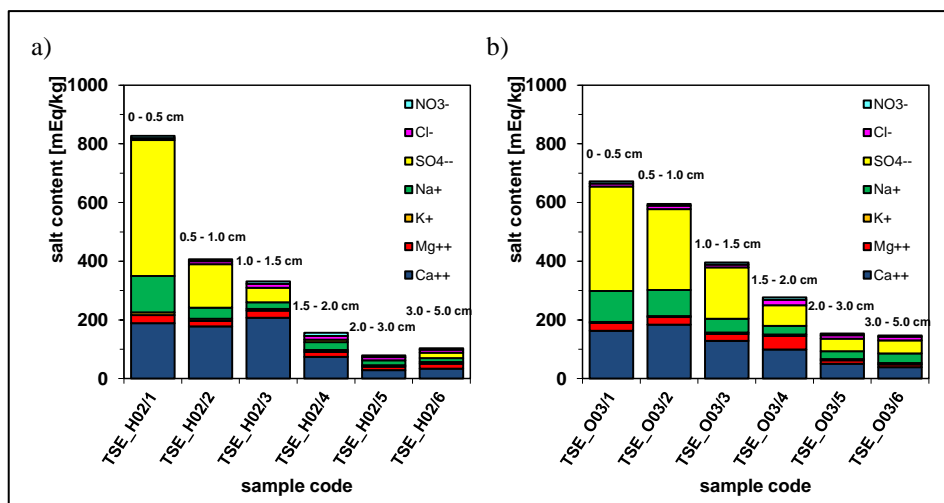
Fig. 3: Salt contents into depth, profile for stone H02 (a) and profile for stone O03(b).

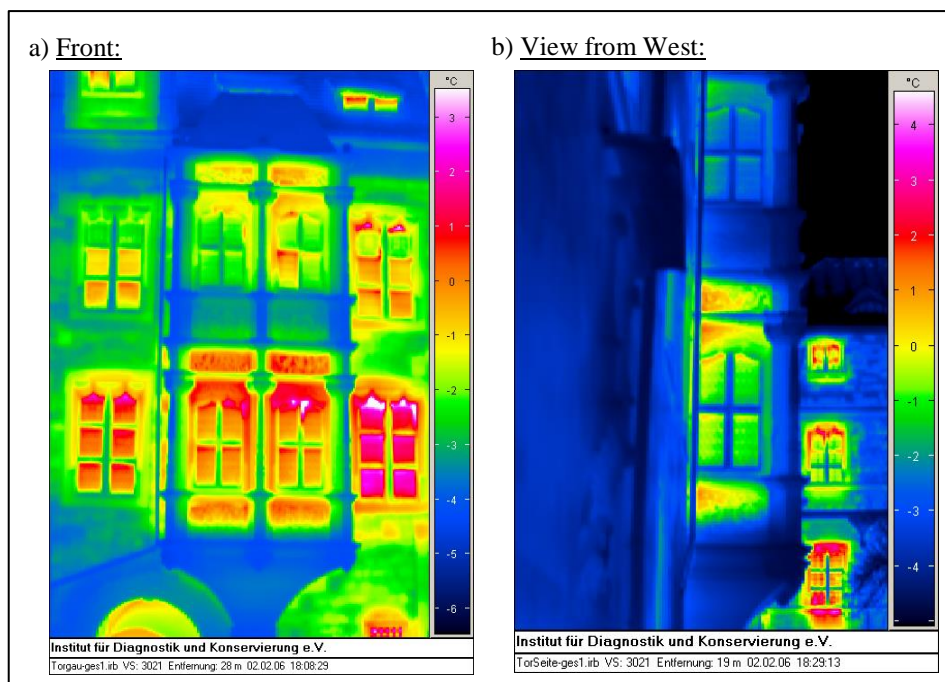
Fig. 5: IR-Thermography 'Schöner Erker'.

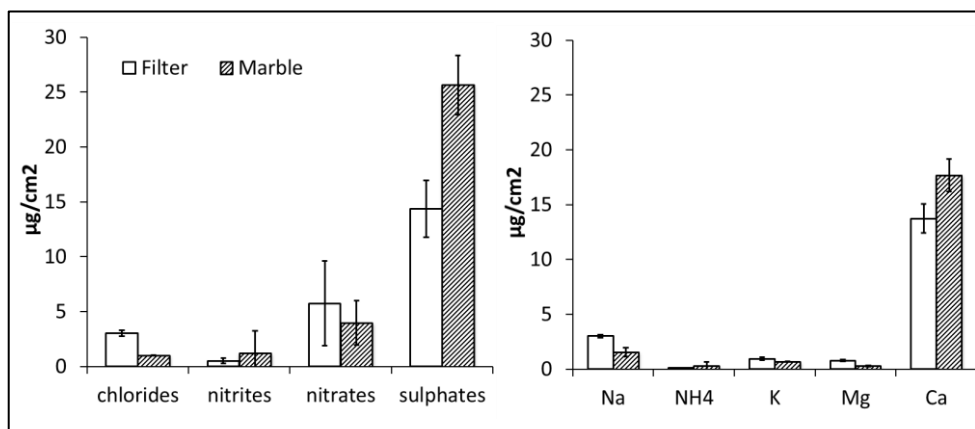
Fig. 3: Anions and cations content of deposit on quartz filter (white bars) and Candoglia marble specimens (grey bars) after six months of sheltered-condition exposition on the façade.

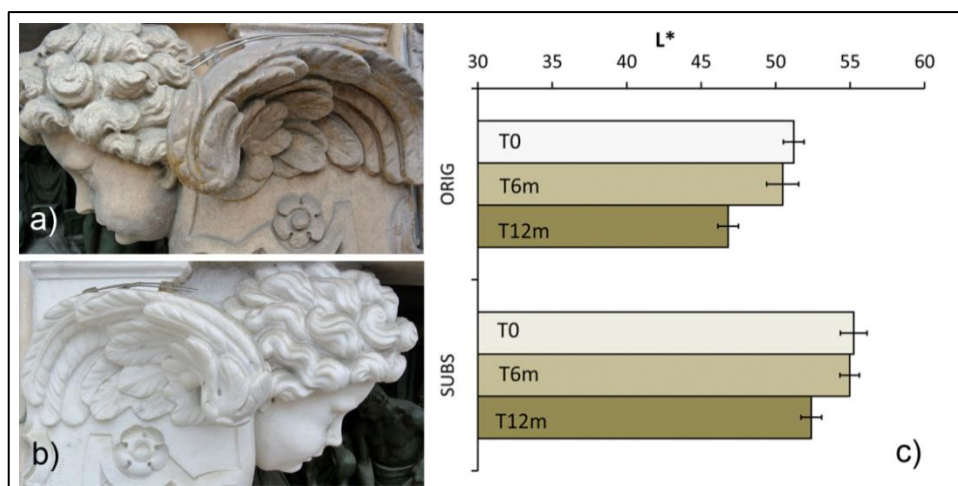
Fig. 4: Photographic documentation of two areas of the colorimetric monitoring characterized by the presence of “original” (a) and more recently substituted (b) marble elements; b) variation of the  $L^*$  parameter within the first year of monitoring.

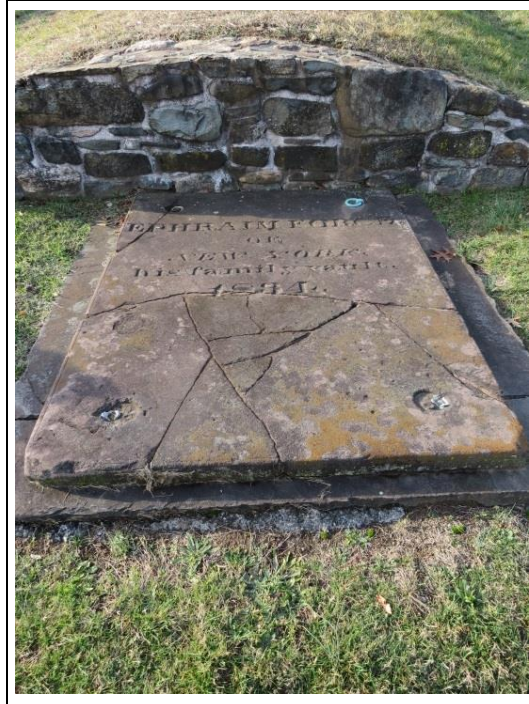
*Fig. 1: Vault Slab with Pinning Repair 10 years later.*

completely intact 10 years later (Fig. 1). In addition, a pinned brownstone marker that was found toppled in the cemetery survived intact. All pinning repairs in the Whippany cemetery are also intact, for the marble and brownstone. The marble markers at Whippany were all thick marble greater than 3 inches in depth. Eight marble markers were pinned at the Orient cemetery as part of their treatment and 6 are still in good condition are both of the sandstone pinning repairs.

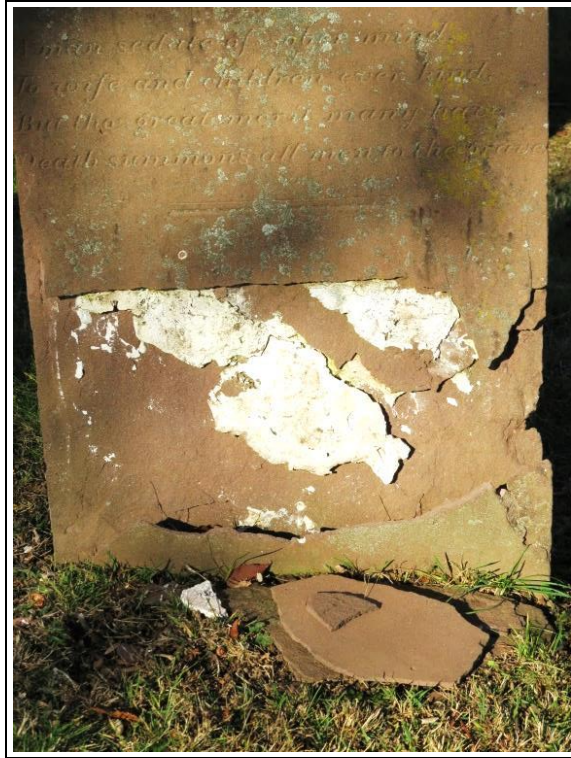
*Fig. 3: Grouting Failure at Bottle Hill Cemetery.*

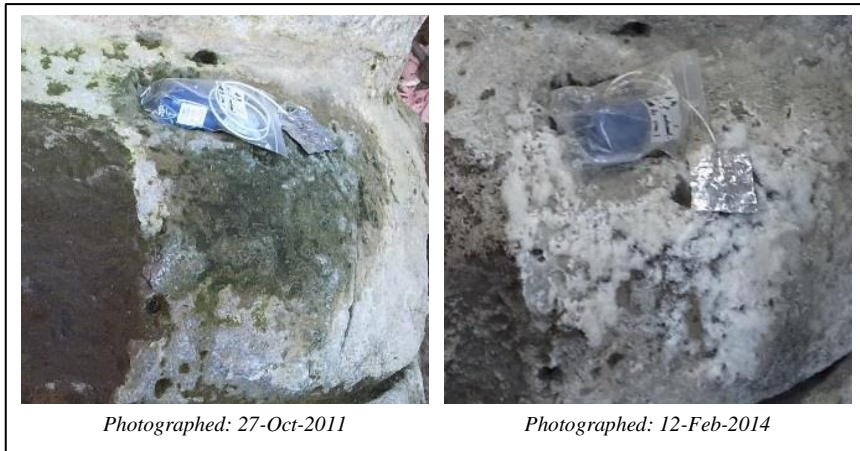
Fig. 2: Seasonal changes in salt deposit.

According to these observations, it appears that salt crystallisation was concentrated in the lower part of the surface of the stone. The distribution of crystallised salt could be affected by water movements. The elevation of the bottom of the stone Buddha and the drainage tunnel is around the same. Therefore, water may have flowed from the ground into the stone. Since salt crystallisation was observed in areas that have deteriorated on the surface of the stone (along a joint or on an exposed surface by scaling), it is suggested that salt was concentrated here owing to high permeability.

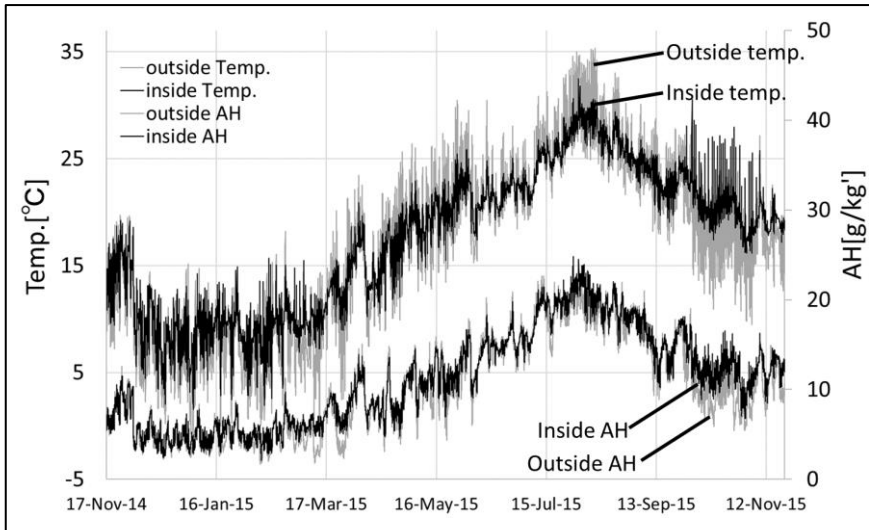
Fig. 5: Inside and outside temperature and absolute humidity.

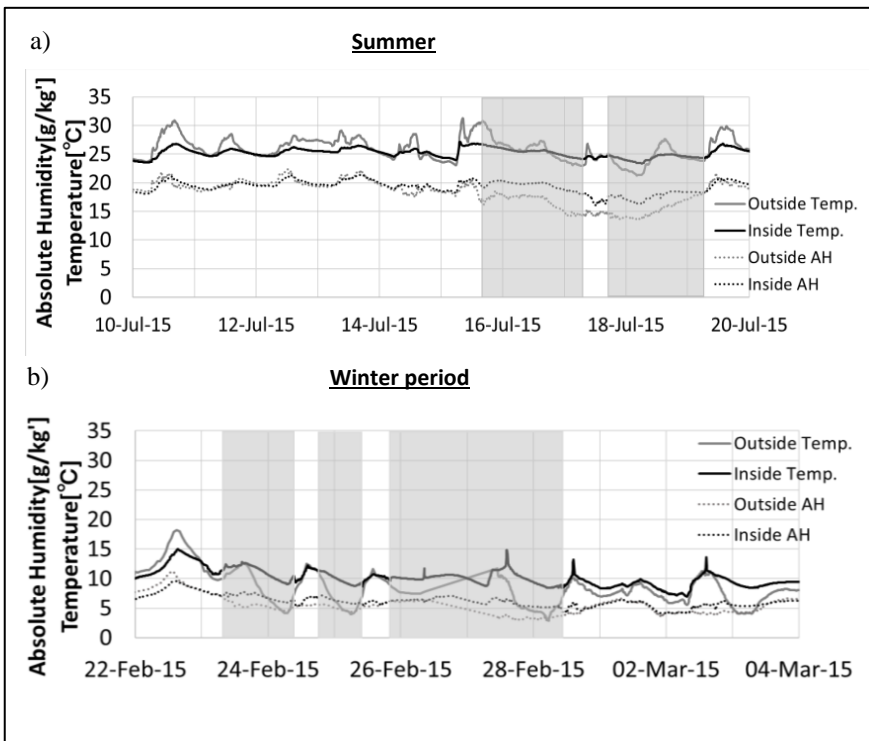
Fig. 6: Absolute humidity and temperature both inside and outside the shelter. The closed-door periods are shaded in grey.

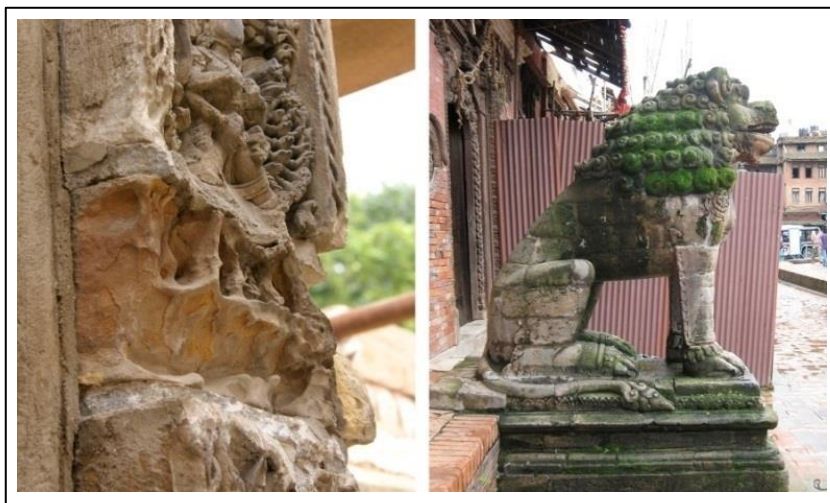
are some of the most common manifestations. Monuments built up of the siliceous sandstone consist mostly of small blocks that can be carried by a single worker. Originally, no mortar pointing or metal pins were used. The bonding between singular blocks was established by simple adding an occasional natural resin dash in the joints. The gaps between the blocks were so small that the carving sometimes continues over more blocks, regardless of their dimensions.

*Fig. 1: Decay patterns and typical construction of monuments made of the siliceous sandstone.*

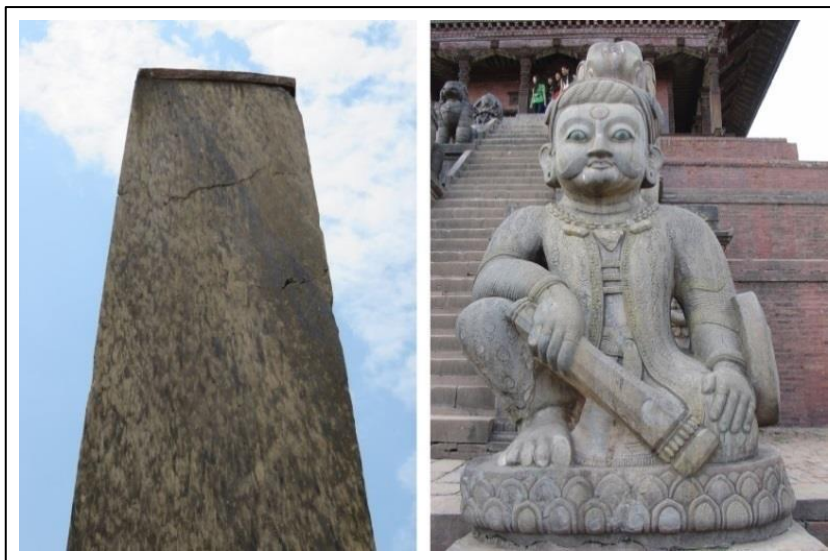
*Fig. 2: Decay patterns and typical construction of monuments made of the metamorphic stone.*

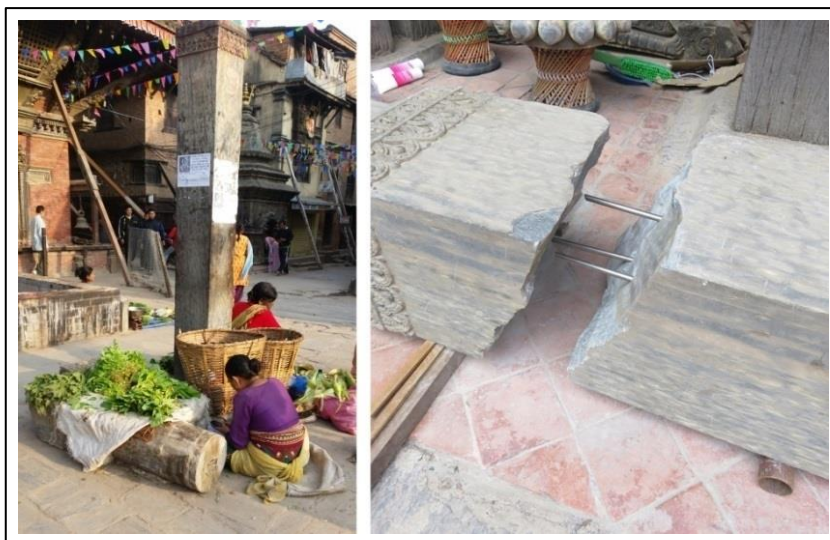
Fig. 3: Partly collapsed pillar used as market stand (left), gluing of broken parts (right).

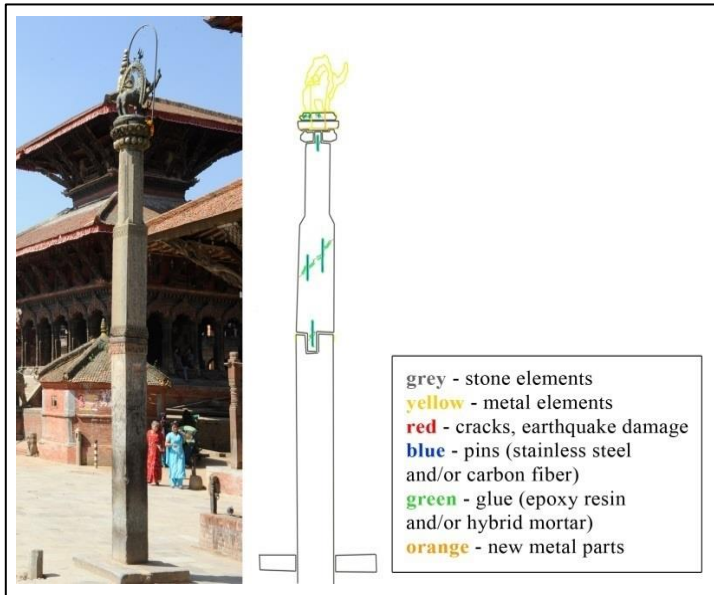
*Fig. 4: Concept for the reassembling of the Lion Statue.*

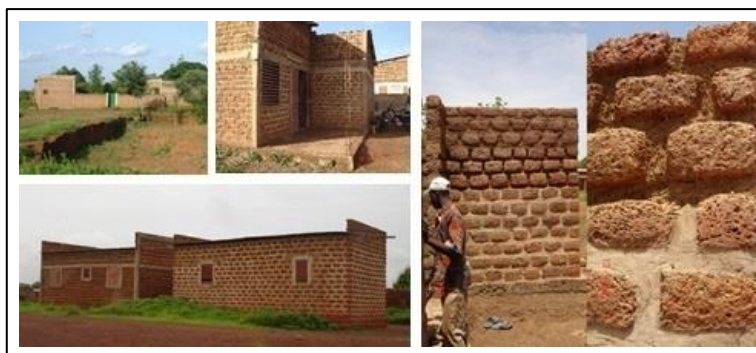
The construction system with LDS usually follows horizontal and parallel shelves where medium and large blocks are mainly used. The mortar used to connect the block is either clay or lime based. Only for the outer walls, the earth is removed on many centimeters and replaced by cement mortar, to avoid erosion (water or wind) actions (see detailed photo in Fig. 2). Inner walls are plastered and painted. In the case of building with concrete frame structure, a floor slab is casted and supported by columns, isolating the roof space. Ventilation holes are created in the upper layer of the walls.

Fig. 2: Typical houses in LDS, either load bearing masonry or with frame concrete.

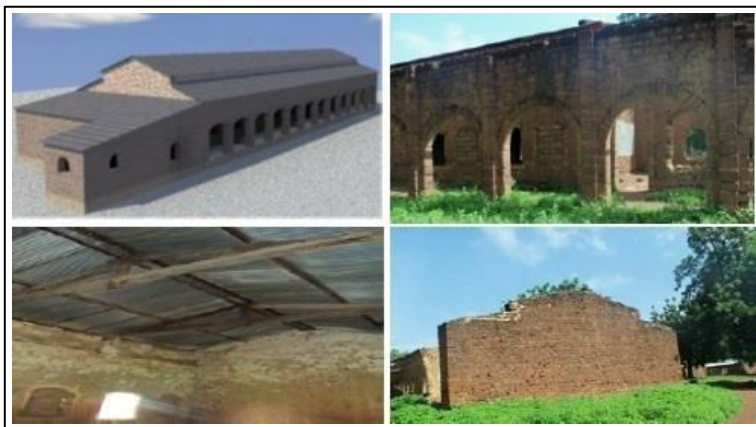
The construction (see Fig. 3) is composed by thick masonry walls (double walls) built with adobe with lime mortar and coated with plaster (clay and cement), whereas the top layers, which are exposed to rain and wind, are made with LDS. The load-bearing walls are made with a mixed masonry of adobe and stone blocks locally quarried. Stone units are connected together by means of a weak lime and sand mortar. The cohesion between the mortar and the stone is weak. All different types of masonry in the structure can be defined as solid masonry.

*Fig. 3: Views of the school and CAD representation.*

A layer of lime plaster and one of lime wash paint were applied to create smooth surface. Masonry blocks have small to medium size (L: 20 cm, h: 15 cm, w: 10 cm) with rough surface, rectangular or square shape. Some of them show a flattened surface. Blocks were used according to their strength, being the weaker used for filling or for coating, whereas the stronger were used for structural purposes. A virtual reconstruction view has been obtained with a CAD application as shown above left in Fig. 3.

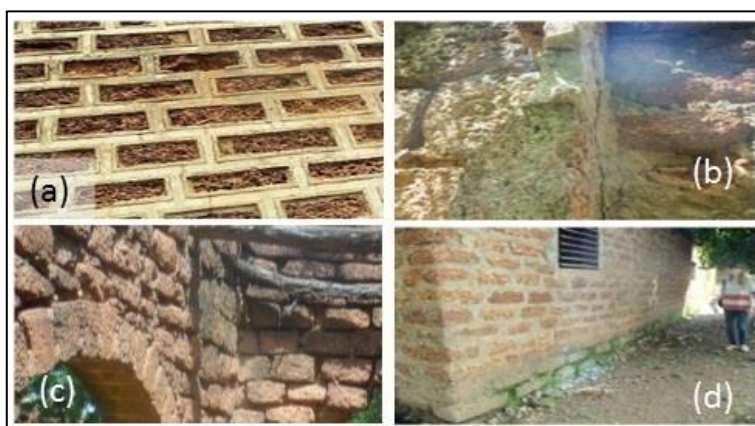
Masonry defects can be associated with several reasons, from a wrong choice of materials to an insufficient quality of the workmanship (Bromblet and Association MEDISTONE, 2010). The local climatic impact can also have a role. Main categories of defects and related causes were defined by direct observations on the surveyed LDS building (the old school and the houses) in Fig. 4:

- Deterioration of the structure of LDS, by atmospheric agents, such as sandy wind and rain, affecting surface stone (a). The block can also be damaged by the cracking associated with the action of water and temperature variation, which facilitates rock degradation and failure (b),
- Disintegration of lime and sand mortar joints, due to the moisture transfer or water runoff action and also because the excessive mortar width between the layers and loss adherence (c),
- Organic deterioration from musk and other plants growth on the lowermost layer of masonry elements, due lack of drained or ventilated space in the basements (d),
- Cracks due to uneven distribution of the loads.

*Fig. 4: Views of the most usual defects observed in LDS structures.*

Some of the above mentioned defects can be avoided by controlling the block production. Good ashlar with rough, parallel surfaces are to be preferred, since these features improve the joint strength, contribute to an even distribution of the loads and reduce the potential accumulation of organic material on joints. The quality of the laying of the block is also an important factor for preventing structure failures. The width of the joints should be kept at a minimum, and in some cases the laying should be carried out even without joint. The quality of the LDS is another key point. Top quality LDS seem to be subject to hardening upon exposure to alternate wetting and drying, but poor to medium quality are not, since granular morphologies are disintegrated by drying and wetting cycles. Masons must be careful when choosing the blocks during construction, trying to use them according to their quality in different places of the structure.

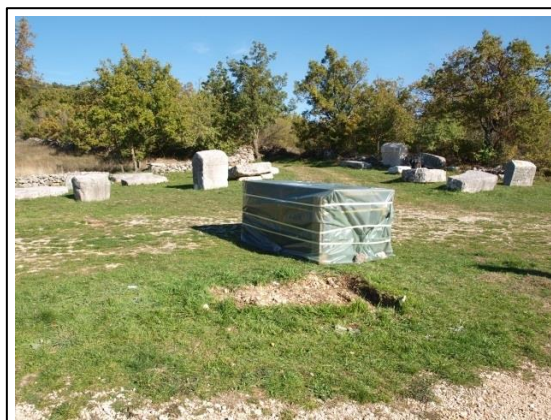
During previous conservation works on stećci (2014), field tests on creation of artificial calcium oxalate layer by poultice (Doherty *et al.* 2007, Pinna *et al.* 2011) or brushing (Mudronja *et al.* 2013) didn't show great results. After finding appropriate or similar "standards" in surrounding quarries, we tried to create protective layer by emerging them in 5% AmOx solution (Mudronja *et al.* 2013; Vanmeert *et al.* 2013). XRD measurements showed similar creation of calcium oxalate layer on surface of all the treated limestones. In addition, some ammonium oxalate (oksammit) bands were detected, which is a left over of the treatment. It will be dissolved with first rain so it does not represent a problem. After successful laboratory tests we immersed the whole stećak in ammonium oxalate bath for 24h using a crane on site (Fig. 5).

Fig. 5: The improvised pool with ammonium oxalate bath, Crljivica.

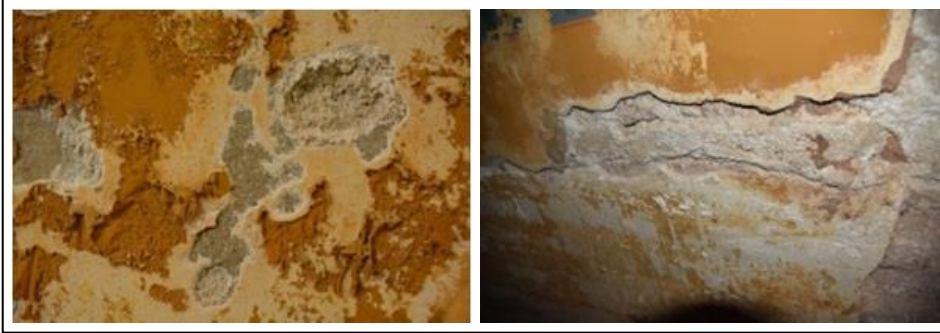
Fig. 2: Exfoliation of inner stucco (left) and middle-layer mortar with salt crystallisation (right)

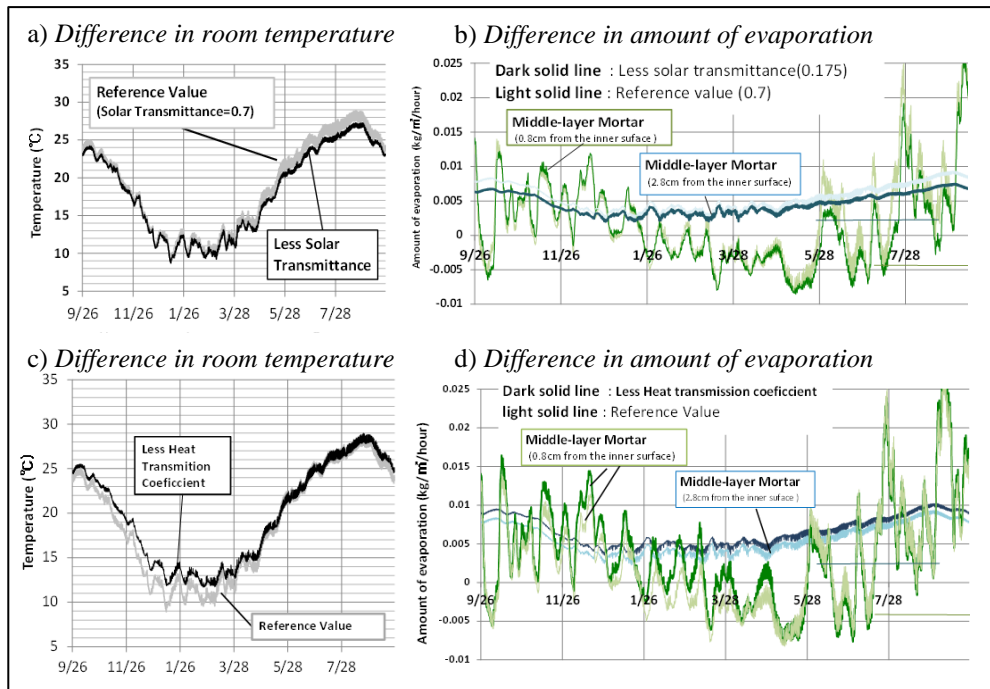
Fig. 11: Difference in room temperature and amount of evaporation.

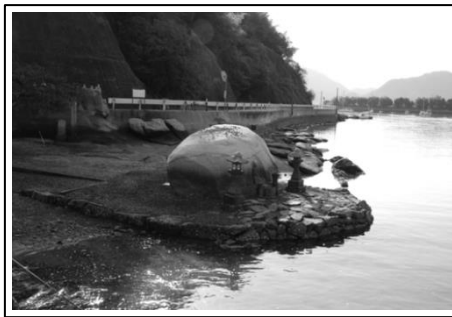
Most of Sagi Island is made of granite from the Late Cretaceous period. The granite boulder into which the Buddha has been carved is exceptionally hard and in good condition compared to the cliff faces on the same coast line and nearby stone Kasatoba (carved stone pillars with hat) from the 17th century, which have decomposed badly and become fragile. This granite boulder may be presumed to be an unweathered rock known as a “core stone.” Its outward appearance differs from that of the decomposed surfaces nearby, which often leads to the mistaken impression that it was brought to the site from elsewhere, but it is believed to be an embedded rock that was originally part of a larger rock body (Fig. 2).

*Fig. 2: Comparison between the boulder on which the Magai-Wareishi-Jizo statue is carved and the surrounding granite cliff face.*

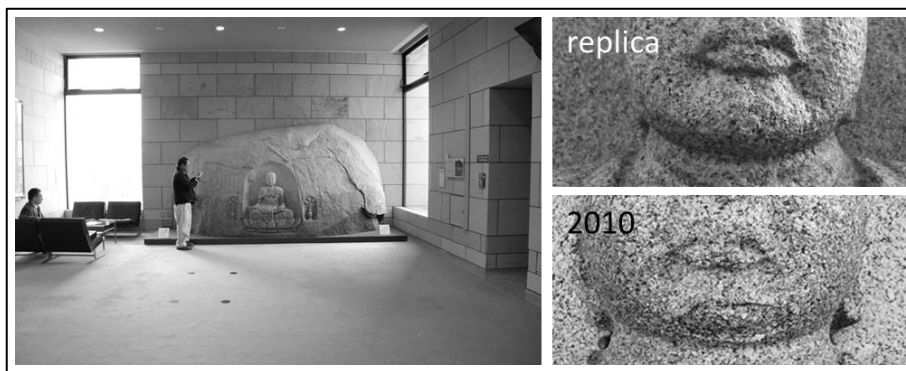
However, visual inspection of the statue has confirmed that there has been some partial surface peeling that has obviously occurred in recent years. To identify the peeling sections, the authors attempted a comparison with a replica of the statue that was cast in 1988 and is currently on display at the Hiroshima Prefectural Museum of History. This comparison confirmed deterioration in six places on the statue and the inscription that had occurred in the past twenty years approximately. For example, peeling of about 1 mm diameter was found on the chin of the stone Buddha (Fig. 3). Moreover, the deterioration is concentrated around the peak high water line, and it is believed that the peeling may be caused by tidal activity, that is, the repeated pattern of soaking at high tide and drying out at low tide.

*Fig. 3: Confirmation of deterioration by comparison with replica.*

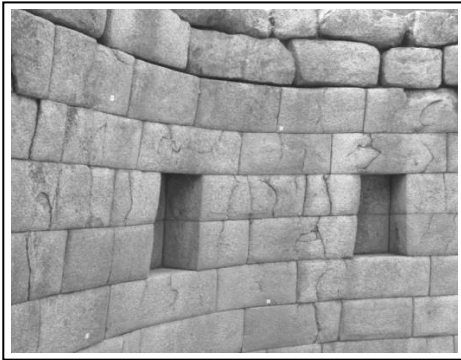
*Fig. 5: Cracks and detachments.*

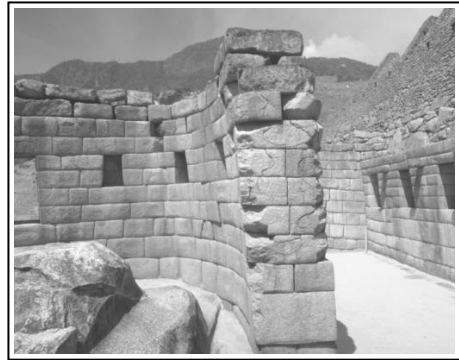
*Fig. 6: Missing parts of edge stones.*

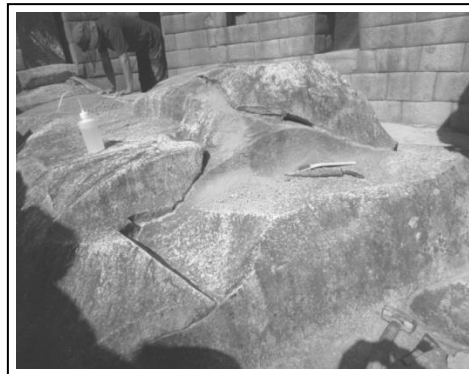
Numbers of cracks are found in the natural rock pedestal in the sacred chamber. These cracks pass through the rock completely in longitudinal direction. The upper part must have been detached. The special clay mixture is presently filled in these fissures to prevent excess water to fill the fissures and plants to grow there (Figures 3 and 7).

*Fig. 7: Decay of natural rock pedestal.*

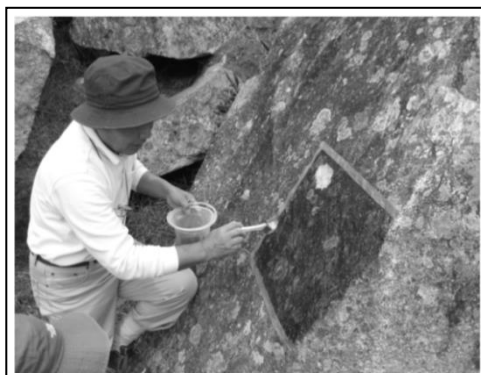
In August of 2012, testing of biocide agent was applied on places where lichen infestations are widespread on a natural rock in the site. The biocide was applied on four area (0.1m<sup>2</sup>) on four sides on north, south, east and west of the natural rock (about 500g/m<sup>2</sup>). After a year, obvious effect is not yet evident, while another testing place with the same biocide agent set outside of the site in March of 2012 shows more apparent effect (Fig. 11).

*Fig. 11: Application of a biocide against lichens.*

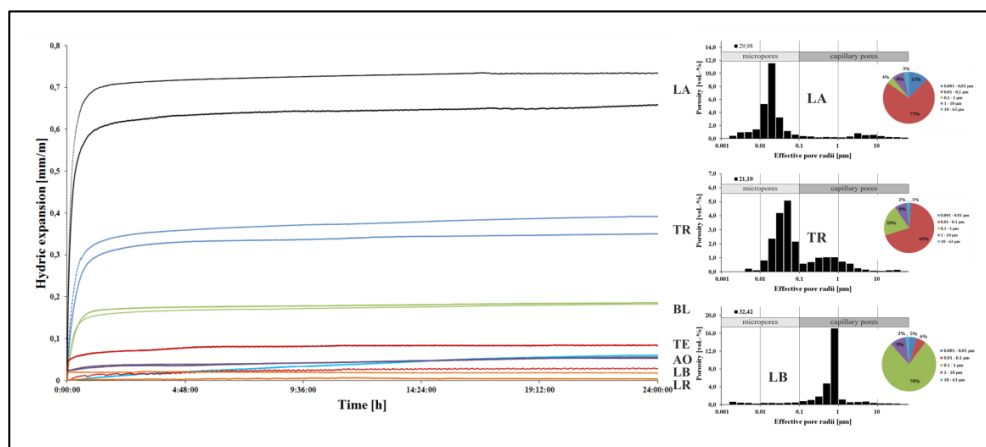
Fig. 3: Hydric expansion correlates with the microporosity on the right.

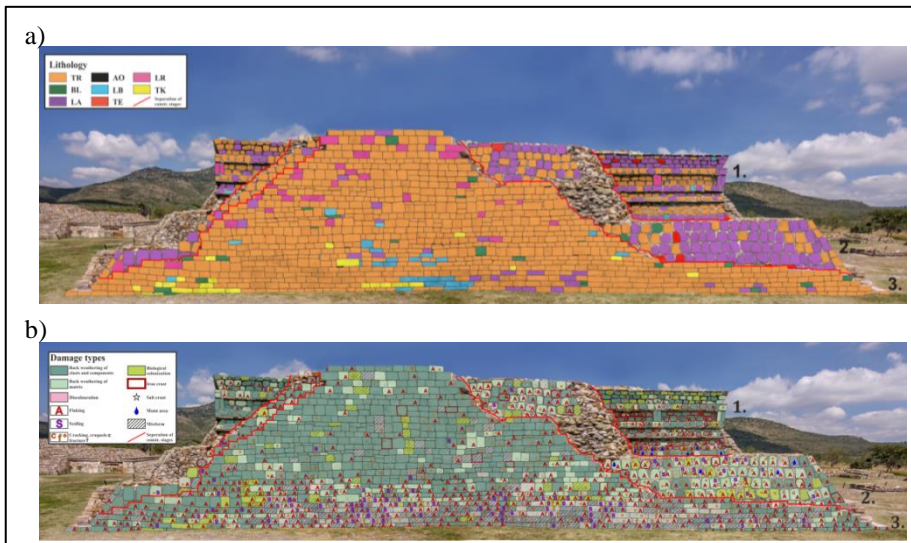
Fig. 5: Mapping of the south side of the pyramid;  
 a) Lithographic mapping; b) Mapping of damage types.  
 1 = 1st construction stage,  
 2 = 2nd construction stage,  
 3 = 3rd construction stage.

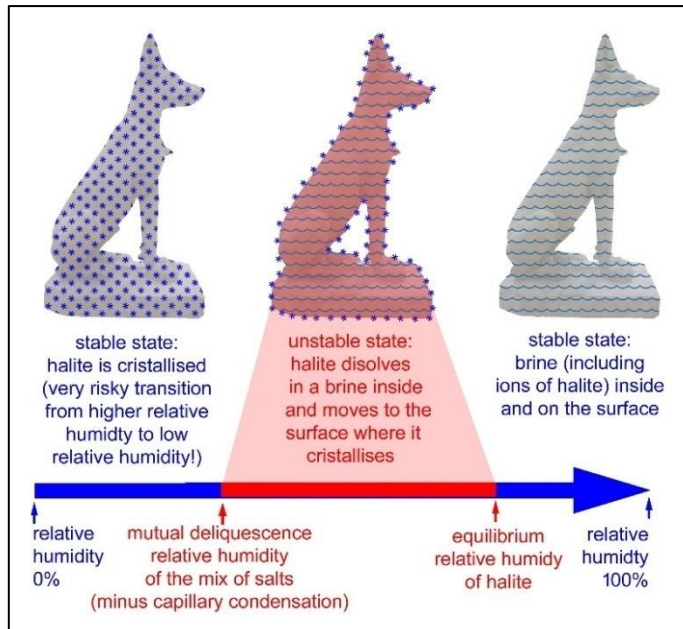
Fig. 5: The transporter brine hypothesis.

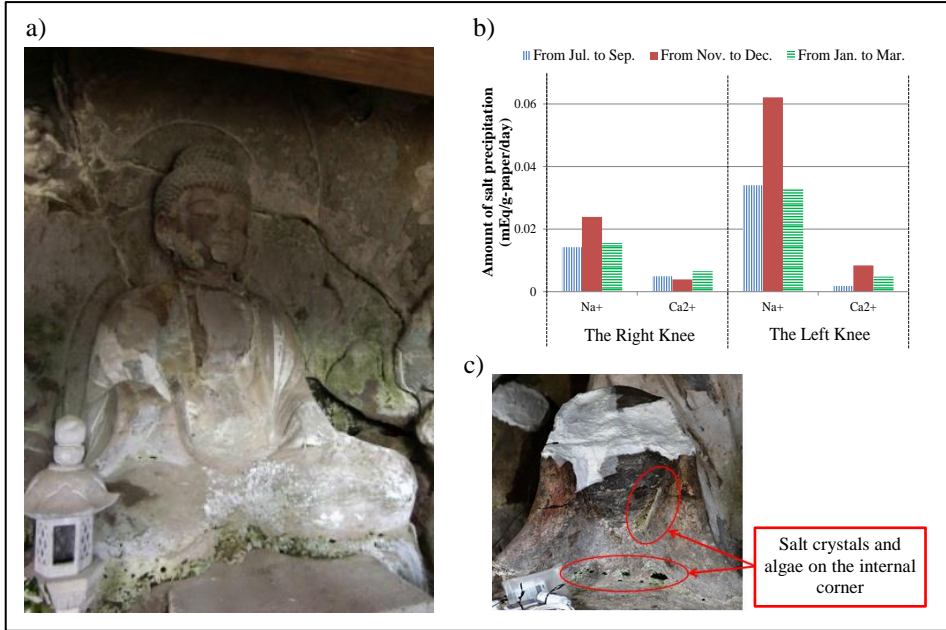
Fig. 2: a) The 'Buddha of Healing', b) Salt precipitation on knees; c) Right knee.

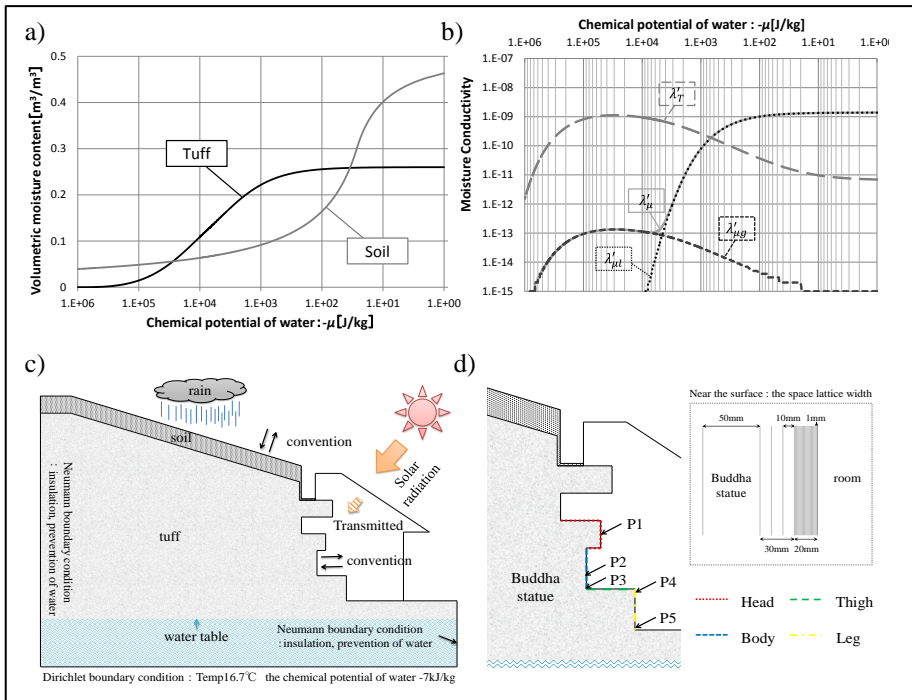
Fig. 3: a) Equilibrium moisture content; b) Moisture conductivity of tuff; c) Analysis model ; d) Analysis positions.

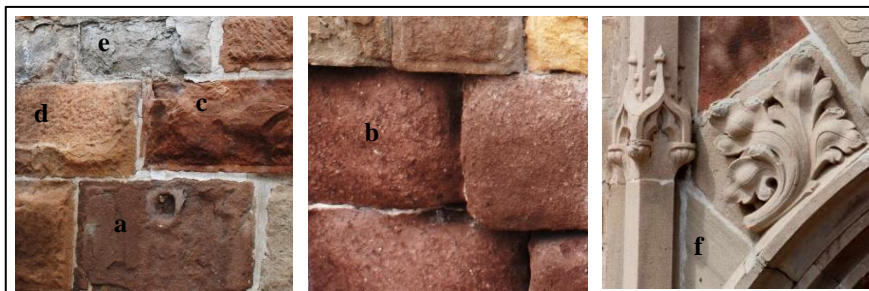
Clay mixture is then an alternative material for capping. Quality of the base clay must be very high. Mixture should contain lime and water-repellant to increase durability and water-resistance property. In Machu Picchu site, good quality clay mixture prepared by a local technician had been used for filling gaps, cracks and missing parts. Generally speaking, the clay obtained from the granite bed is known to be high in quality. For these reasons, use of this clay is considered to apply.

*Fig. 1: details of the 6 different sandstone patterns.*

- a) Type 1: fine wine lees colour sandstone
- b) Type 2: coarse wine lees colour sandstone including rock fragments of several cm
- c) Type 3: fine red sandstone of restoration
- d) Type 4: yellow sandstone
- e) Type 5: grey-green sandstone
- f) Type 6: grey-green restoration sandstone

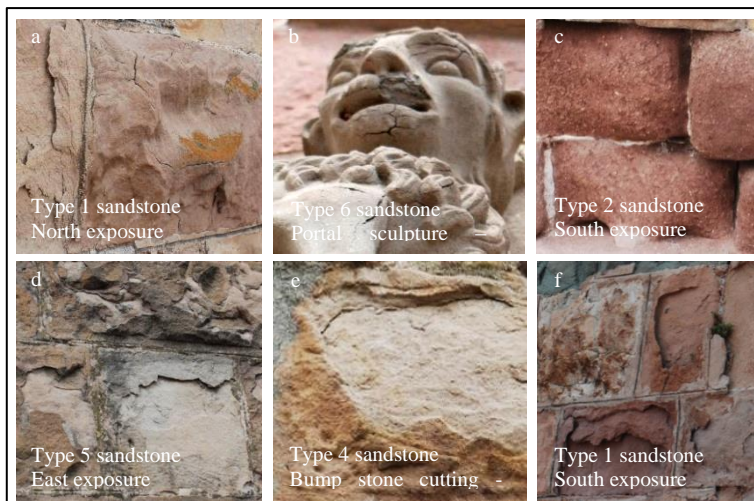
*Fig. 2: Details of craquele, scaling and granular disintegration patterns.*

Craquele is a degradation level which evolves towards the scaling (Fig.2a and 2f); it is due to constraints which occur in stone subsurface, under the superficial epidermis part, on the total stone surface. The observed craquele pattern seems to be characteristic of a degradation mechanism due to intrinsic properties of the stone. The picture f detail shows that it is not significant of interactions with joint mortars. The picture e documents the yellow type 4 sandstone scaling. It shows that the more the stone is exposed to the imbibition-evaporation phenomena, the more it scales. The stone cutting in bumps on the bell tower enhances the degradation. Scaling affects the 6 sandstone patterns of the episcopal group of Fréjus; nevertheless, the grey-green of types 5 and 6 sandstones are particularly damaged. So craquele and scaling affect as much, and even in a spectacular way, the type 6 grey-green sandstone used in a recent restoration (less than 30 years ago). Besides, granular disintegration is a phenomena which widely affects the type 2 coarse wine lees sandstone (Fig. 2c), especially in capillary rising zones.

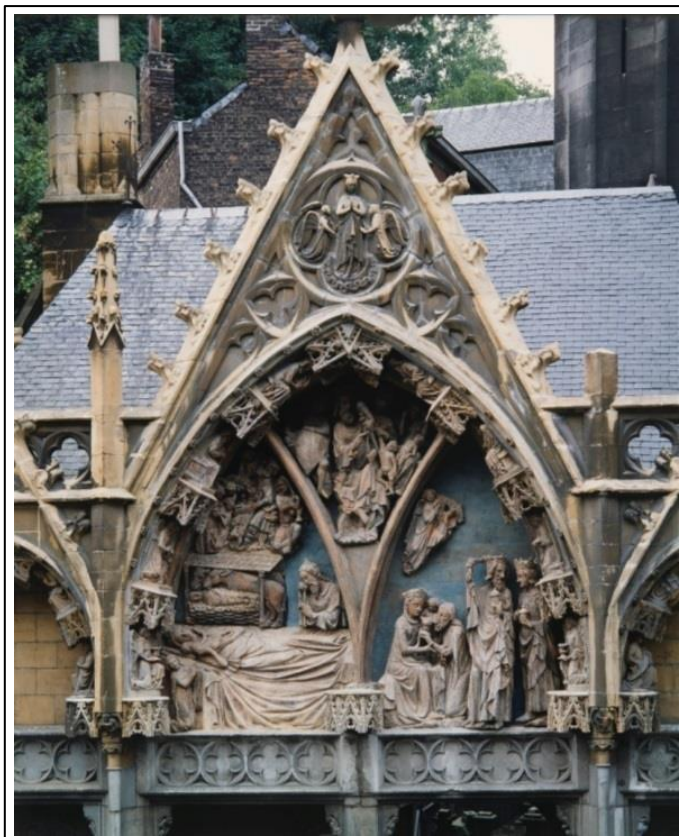
The first step of the treatment consisted of taking away pigeon's nests and excreta. Then the salt crystals on the surface, the encrustation of dust and the whitewashes were removed mechanically. During this procedure, the original polychromy was fixed, and the stone was consolidated where necessary. At first, the stone consolidation was carried out by injecting ethyl silicate (Goldschmidt Tegovacom V). After unsatisfactory result, it was decided to consolidate with injections of epoxy resins (Araldite AY 103-HY956 diluted with methanol 10%). These operations were repeated until the desired result was achieved. A mortar composed of lime stone powder mixed with pva emulsion (10%) was used. The background

was overpainted with a blue paint composed of a mixture of casein and lime with blue pigments. As finishing layer, a water-diluted silicone was applied over all the surfaces of the portal. For protection against pigeons, a nylon net with 3 centimetres square was placed.

*Fig. 2: Portal after treatment in 1989, © KIK/IRPA, Bruxelles.*

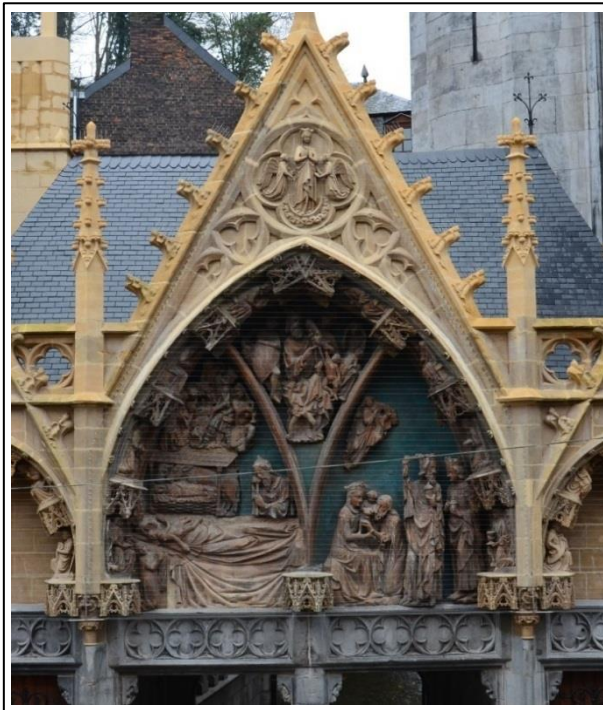
*Fig. 8: Portal after maintenance treatment in 2014.*

Following the conventions of today, we probably would not use the same methods, materials and techniques as in this 1988-89 treatment, however, one cannot fault their results. The fixing of the polychromy is still good; stones and mortars repair are in a good state of preservation; the water repellent is still active. Only the painted background presents colour alterations from blue to greenish grey. There are few localized zones, well protected, which present a blue appearance probably close to the original state of the whitewash applied in 1989. The maintenance treatment with its main goal of going back to the state after the restoration of 1988-89, was achieved with a light removal of dust, soft superficial cleaning treatment and a retouching treatment of the discoloured blue background.

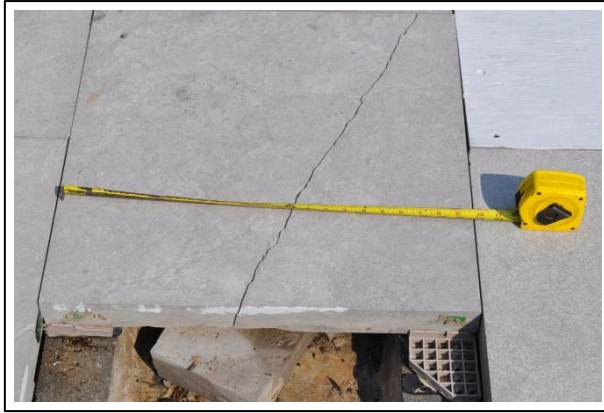
Thermally finished Pompignan limestone pavers sized 55.9 cm square by 5.1 cm thick (22" square by 2" thick), mounted on plastic composite shims atop pedestals, with open joints, were encountered at the project location. Failed pavers exhibited cracking and/or delamination.

*Fig. 1: Typical failed paver.*

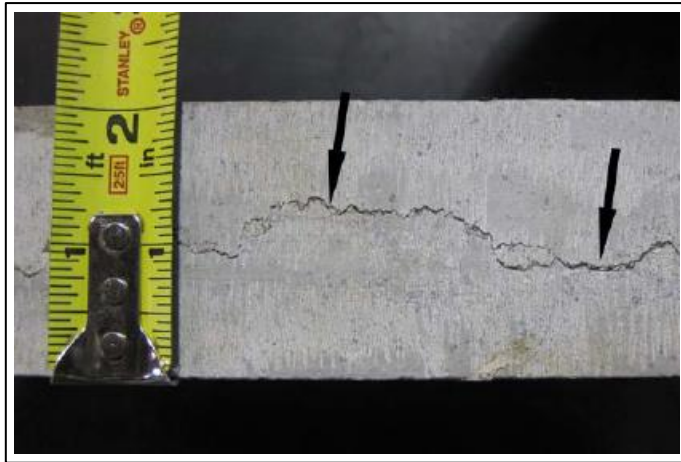
A stylolite is a type of geological cleavage across which dissolution has occurred during compaction of the original sediment. Insoluble matter such as clay and other silicates collect at the dissolution plane. Stylolites in the stones examined manifested as saw toothed bands in both horizontal and, less commonly, vertical planes as oriented to the intended exposed face of the stone. The more notable stylolites usually presented as a single continuous to semi-continuous seam located somewhere between mid-depth and the inside surface of the stone. Stylolites within the plane of paving stones were noted to exhibit a series of incipient microcracks oriented parallel to the stone face in its installed position.

*Fig. 3: Microcracks parallel to stone face.*

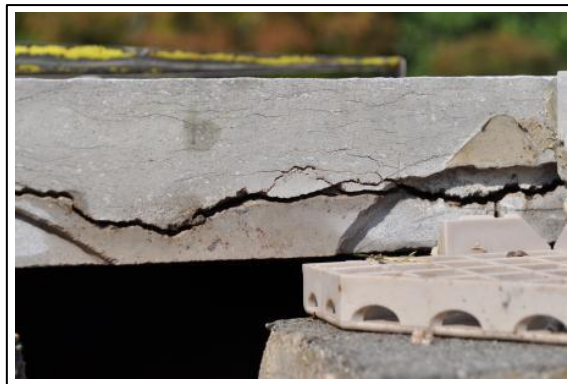
Two failure modes were identified in paving stones; both are closely related to the pre-existing geological structure. One is a fracture that splits the stone coincidental with a microscopic vein set. The other is an incipient in-plane crack with secondary gypsum crystallization coincidental with main stylolitic surfaces.

*Fig. 7: Typical delaminated Paver.*
